**PROPERTY NINJA**  
BUILDING INSPECTION

# WELCOME TO YOUR PROPERTY NINJA REPORT

**PROPERTY ADDRESS:** X X X X X X , Dubai.

During Snagging Property Ninja noticed **234 Snag** Issues to be rectified for **App X X X X X X , Dubai.**

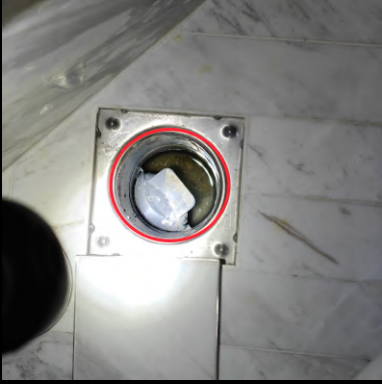
| SI NO | LOCATION | TRADE | PICTURE | SNAG COMMENTS |
|---|---|---|---|---|
| 1 | General & Common Issues | Floor Drain | | Dust & debris inside all the drain to be cleaned. |

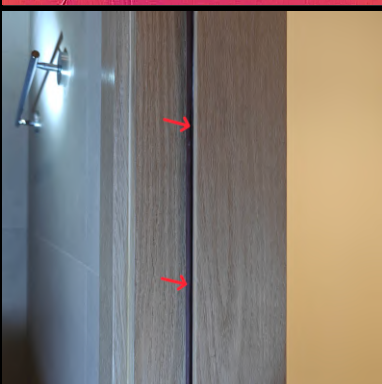
| SI NO | LOCATION | TRADE | PICTURE | SNAG COMMENTS |
|---|---|---|---|---|
| 3 | General & Common Issues | Door & Frame | | Improper installation of door frame rubber seals was observed on multiple doors throughout the apartment. |

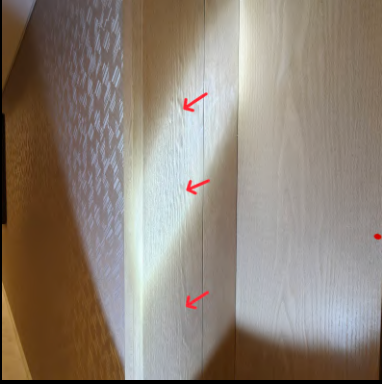
| SI NO | LOCATION | TRADE | PICTURE | SNAG COMMENTS |
|---|---|---|---|---|
| 5 | Entrance | Main Door & Frame | | Surface appears damaged with visible air gaps - frame lipping is also damaged and bulging outward. |

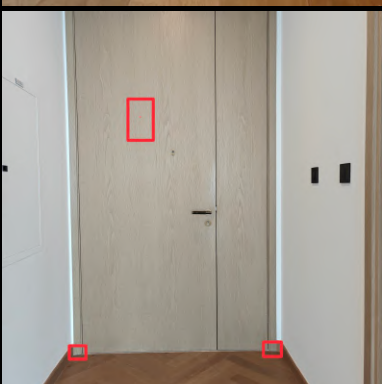
| SI NO | LOCATION | TRADE | PICTURE | SNAG COMMENTS |
|---|---|---|---|---|
| 8 | Entrance | Main Door & Frame | | Noticeable scratches on door. Missing silicone at frame bottom termination - Gaps. |

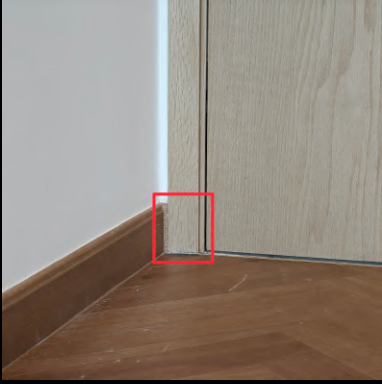
| SI NO | LOCATION | TRADE | PICTURE | SNAG COMMENTS |
|---|---|---|---|---|
| 8 | Entrance | Main Door & Frame | | Missing silicone at frame bottom termination - Gaps. |

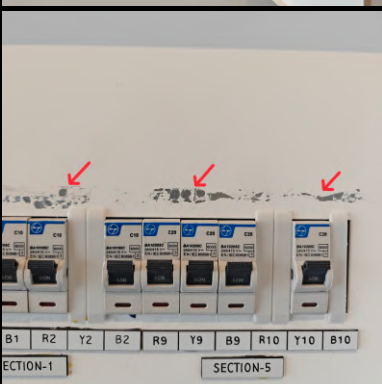
| SI NO | LOCATION | TRADE | PICTURE | SNAG COMMENTS |
|---|---|---|---|---|
| 9 | Entrance | Electric DB | | Trip handles of the RCCB are broken and need to be replaced to ensure proper safety operation. |

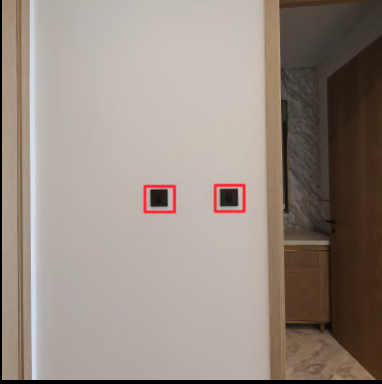
| SI NO | LOCATION | TRADE | PICTURE | SNAG COMMENTS |
|---|---|---|---|---|
| 12 | Entrance | Electric Switch | | Switch button appears tilted in its installation. Proper alignment and fixing are recommended. |

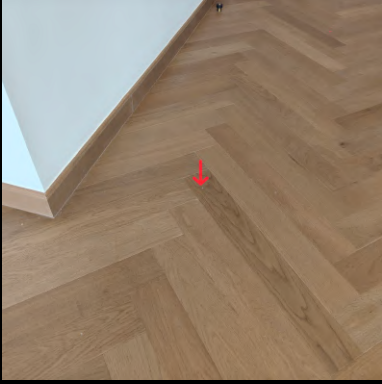
| SI NO | LOCATION | TRADE | PICTURE | SNAG COMMENTS |
|---|---|---|---|---|
| 15 | Entrance | Wooden Flooring | | Scratches & damages. |

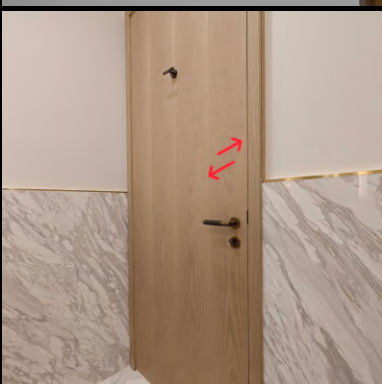
| SI NO | LOCATION | TRADE | PICTURE | SNAG COMMENTS |
|---|---|---|---|---|
| 18 | Powder Room | Door & Frame | | Rattling doors. |

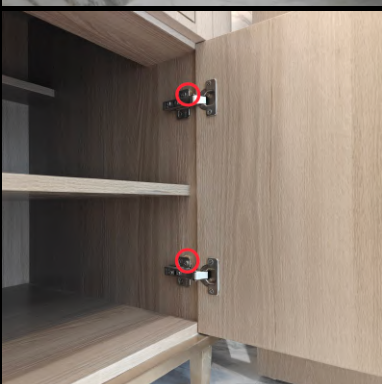
| SI NO | LOCATION | TRADE | PICTURE | SNAG COMMENTS |
|---|---|---|---|---|
| 22 | Powder Room | Vanity Cabinet | | Temperory & unwanted support to be removed. |

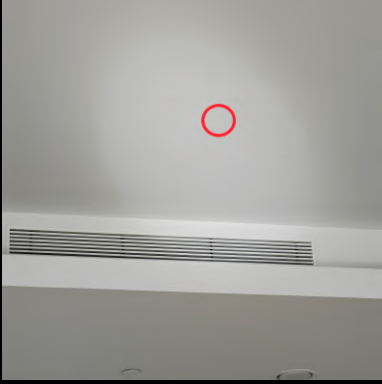
| SI NO | LOCATION | TRADE | PICTURE | SNAG COMMENTS |
|---|---|---|---|---|
| 24 | Living | Ceiling | | Chipped surface. |

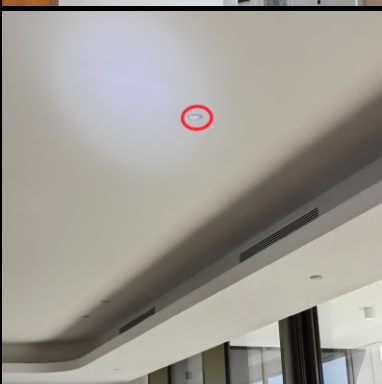
| SI NO | LOCATION | TRADE | PICTURE | SNAG COMMENTS |
|---|---|---|---|---|
| 27 | Living | Electric Light | | Improve finishing around light termination. |

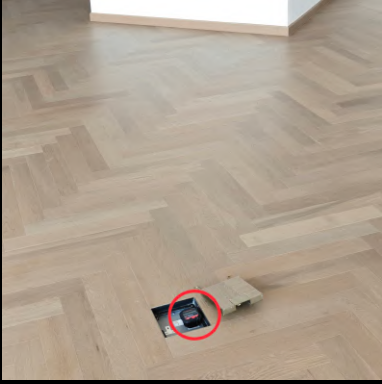
| SI NO | LOCATION | TRADE | PICTURE | SNAG COMMENTS |
|---|---|---|---|---|
| 29 | Living | Floor Electric Socket | | No power supply in electric sockets. |

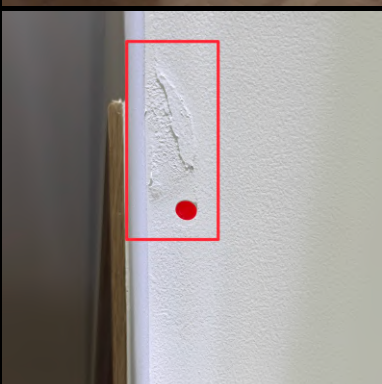
| SI NO | LOCATION | TRADE | PICTURE | SNAG COMMENTS |
|---|---|---|---|---|
| | Living | Wall | | Chipped wall surface. |

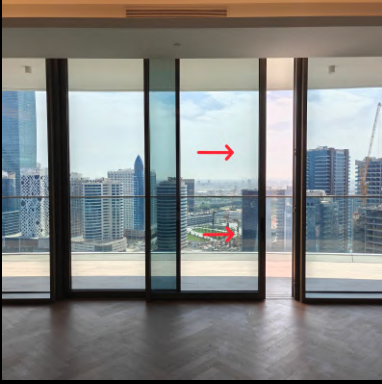
| SI NO | LOCATION | TRADE | PICTURE | SNAG COMMENTS |
|---|---|---|---|---|
| 32 | Living | Sliding Glass Door | | Sliding glass door is difficult to close when fully opened. Adjustment or maintenance is recommended to ensure smooth operation. |

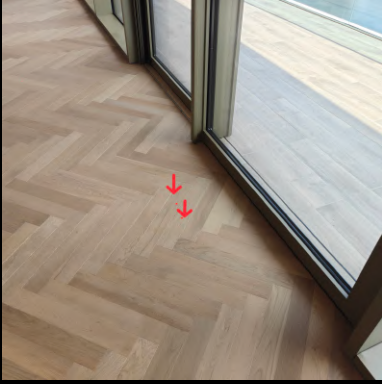
| SI NO | LOCATION | TRADE | PICTURE | SNAG COMMENTS |
|---|---|---|---|---|
| 36 | Living | Wooden Flooring | | Noticeable scratches. |

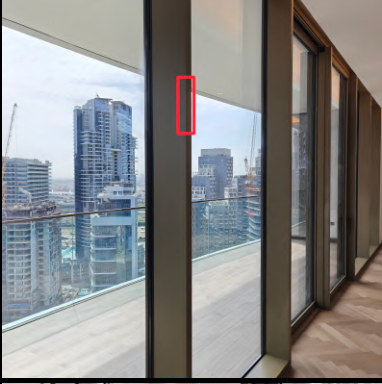
| SI NO | LOCATION | TRADE | PICTURE | SNAG COMMENTS |
|---|---|---|---|---|
| 39 | Dining | Sliding Glass Door | | Paint damages. |

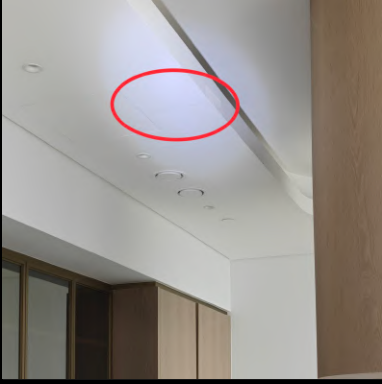
| SI NO | LOCATION | TRADE | PICTURE | SNAG COMMENTS |
|---|---|---|---|---|
| 41 | Show Kitchen | Ceiling | | Uneven surface & paint finishing. |

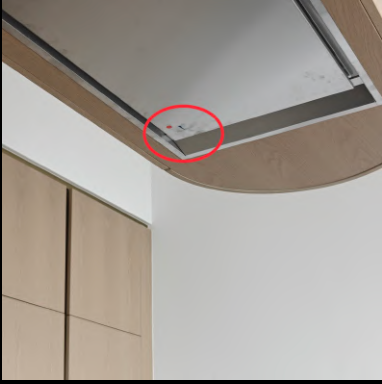
| SI NO | LOCATION | TRADE | PICTURE | SNAG COMMENTS |
|---|---|---|---|---|
| 46 | Show Kitchen | Kitchen Hood | | Noticeable scratches. |

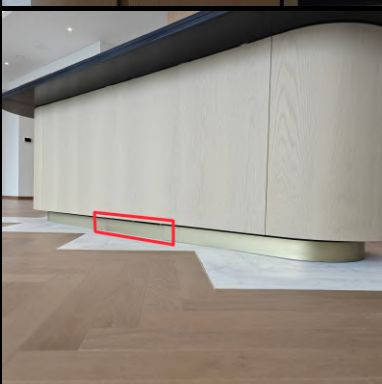
| SI NO | LOCATION | TRADE | PICTURE | SNAG COMMENTS |
|---|---|---|---|---|
| 49 | Show Kitchen | Cabinet | | Improper installation of bottom skirting. |

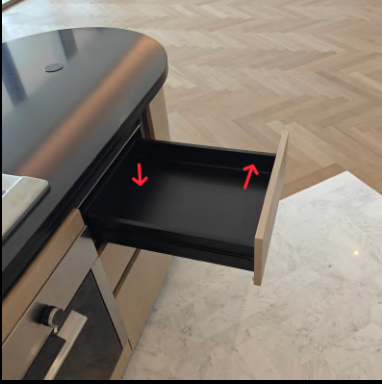
| SI NO | LOCATION | TRADE | PICTURE | SNAG COMMENTS |
|---|---|---|---|---|
| 51 | Show Kitchen | Cabinet | | Multiple scratches on drawer surface. |

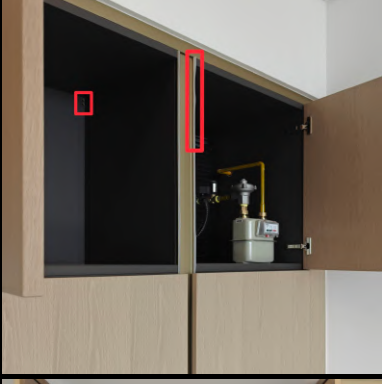
| SI NO | LOCATION | TRADE | PICTURE | SNAG COMMENTS |
|---|---|---|---|---|
| 52 | Show Kitchen | Cabinet | | Improper installation of rubber seals. Seal holes at back panel. |

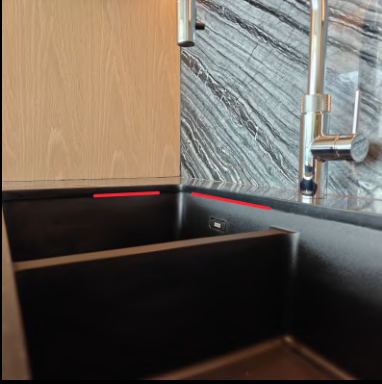
| SI NO | LOCATION | TRADE | PICTURE | SNAG COMMENTS |
|---|---|---|---|---|
| 54 | Show Kitchen | Sink | | Inconsistent/Missing silicone between sink & countertop termination. |

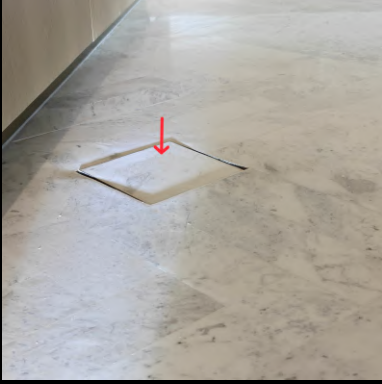
| SI NO | LOCATION | TRADE | PICTURE | SNAG COMMENTS |
|---|---|---|---|---|
| 57 | Show Kitchen | Floor Drain | | Drain cover do not close properly. |

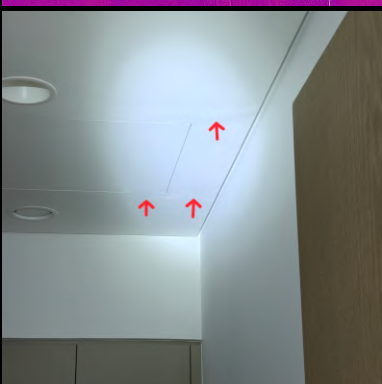
| SI NO | LOCATION | TRADE | PICTURE | SNAG COMMENTS |
|---|---|---|---|---|
| 60 | Back Kitchen & Laundry | Ceiling | | Uneven surface. |

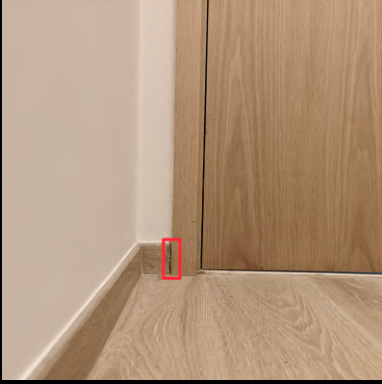
| SI NO | LOCATION | TRADE | PICTURE | SNAG COMMENTS |
|---|---|---|---|---|
| 63 | Back Kitchen & Laundry | Door & Frame | | Gaps at skirting termination - Missing silicone. |

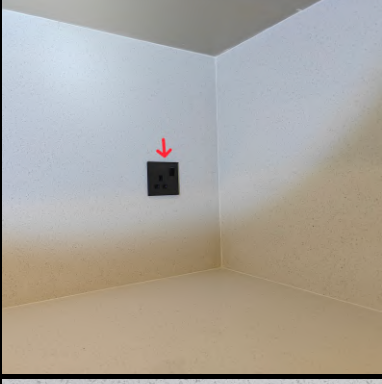
| SI NO | LOCATION | TRADE | PICTURE | SNAG COMMENTS |
|---|---|---|---|---|
| 66 | Back Kitchen & Laundry | Electric Socket | | Improper termination - Gaps. |

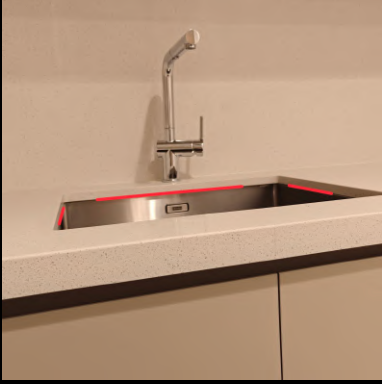
| SI NO | LOCATION | TRADE | PICTURE | SNAG COMMENTS |
|---|---|---|---|---|
| 67 | Back Kitchen & Laundry | Sink | | Inconsistent/Missing silicone between sink & countertop termination. |

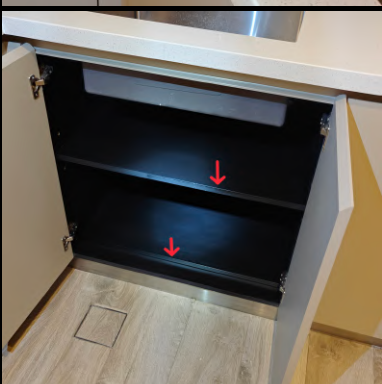
| SI NO | LOCATION | TRADE | PICTURE | SNAG COMMENTS |
|---|---|---|---|---|
| 70 | Back Kitchen & Laundry | Cabinet | | Edge damages. |

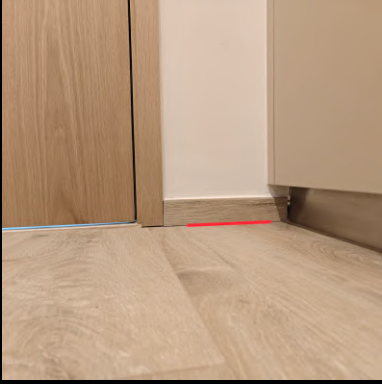
| SI NO | LOCATION | TRADE | PICTURE | SNAG COMMENTS |
|---|---|---|---|---|
| 72 | Back Kitchen & Laundry | Floor Tiles | | Missing grouts along tile skirting. |

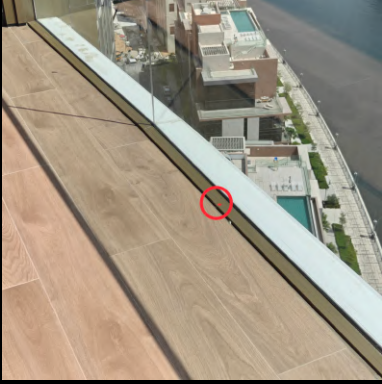
| SI NO | LOCATION | TRADE | PICTURE | SNAG COMMENTS |
|---|---|---|---|---|
| 77 | Balcony | Guardrail | | Paint damages at railing bottom frame. |

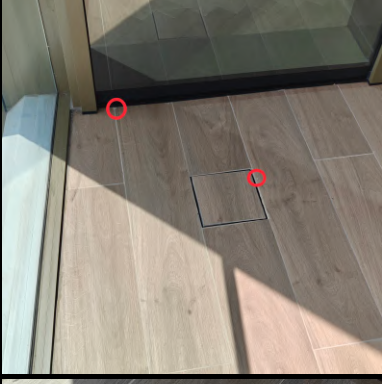
| SI NO | LOCATION | TRADE | PICTURE | SNAG COMMENTS |
|---|---|---|---|---|
| 79 | Balcony | Floor Tiles | | Chipped tiles. |

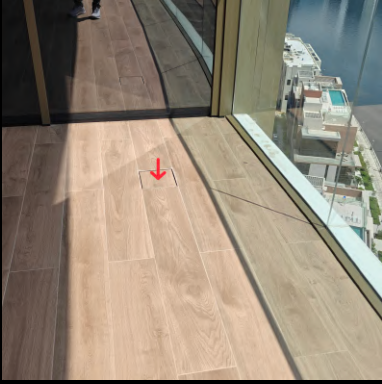
| SI NO | LOCATION | TRADE | PICTURE | SNAG COMMENTS |
|---|---|---|---|---|
| 81 | Balcony | Rain Water Drain | | Rainwater drain cover is stuck - Could not be opened during the inspection. |

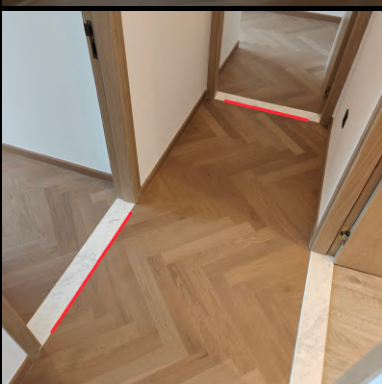
| SI NO | LOCATION | TRADE | PICTURE | SNAG COMMENTS |
|---|---|---|---|---|
| 84 | Passage | Wooden Flooring | | Gaps between wooden flooring & threshold termination. |

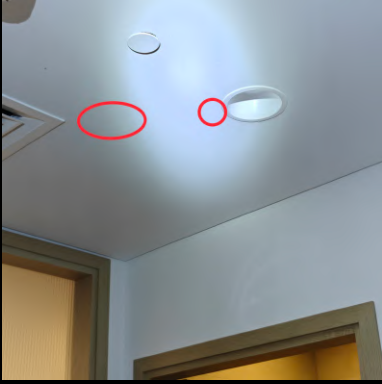
| SI NO | LOCATION | TRADE | PICTURE | SNAG COMMENTS |
|---|---|---|---|---|
| 86 | Maids Room | Ceiling | | Chipped & uneven surface. |

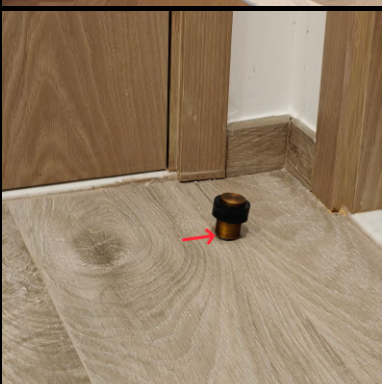
| SI NO | LOCATION | TRADE | PICTURE | SNAG COMMENTS |
|---|---|---|---|---|
| 89 | Maids Room | Door & Frame | | Gaps at frame bottom termination & Loosely fit door stoppers. |

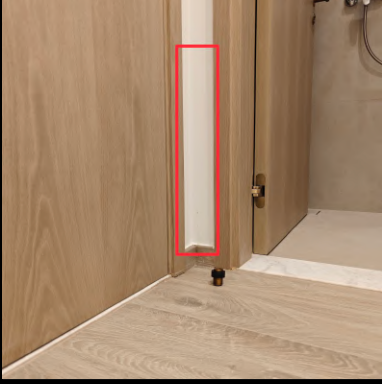
| SI NO | LOCATION | TRADE | PICTURE | SNAG COMMENTS |
|---|---|---|---|---|
| 91 | Maids Room | Wall | | Stains & marks. |

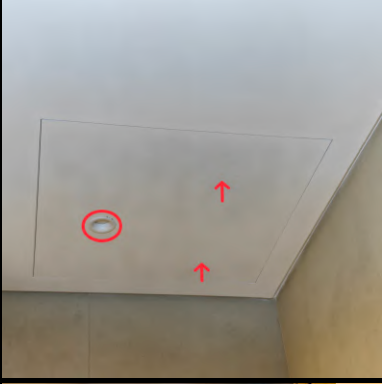
| SI NO | LOCATION | TRADE | PICTURE | SNAG COMMENTS |
|---|---|---|---|---|
| 94 | Maids Washroom | Ceiling | | Stains on AD & poor finishing around light termination. |

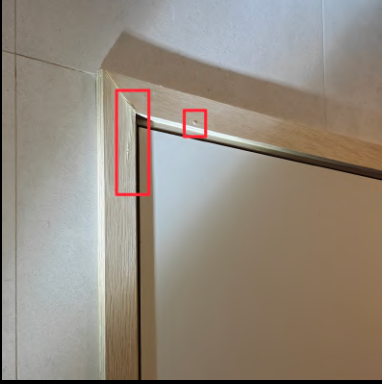
| SI NO | LOCATION | TRADE | PICTURE | SNAG COMMENTS |
|---|---|---|---|---|
| 96 | Maids Washroom | Door & Frame | | Damages on frame. |

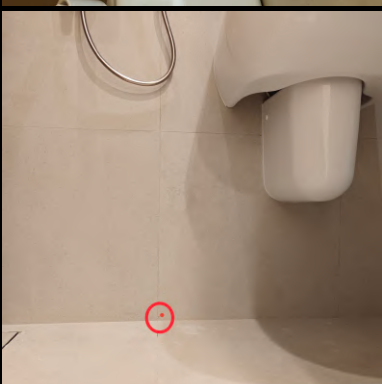
| SI NO | LOCATION | TRADE | PICTURE | SNAG COMMENTS |
|---|---|---|---|---|
| 99 | Maids Washroom | Wall Tiles | | Chipped tiles. |

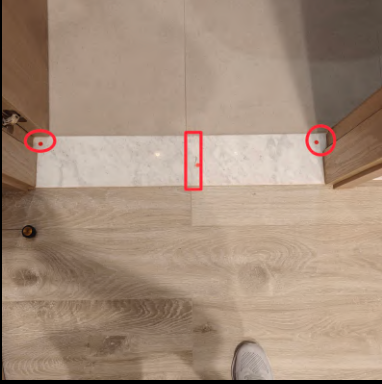
| SI NO | LOCATION | TRADE | PICTURE | SNAG COMMENTS |
|---|---|---|---|---|
| 101 | Maids Washroom | Floor Threshold | | Cracks & improper crack rectification. |

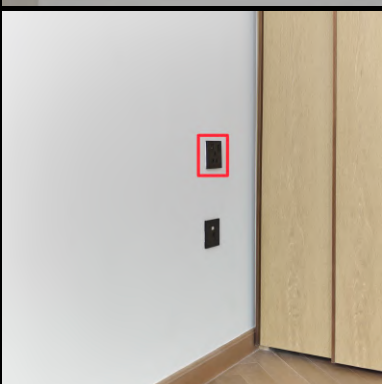
| SI NO | LOCATION | TRADE | PICTURE | SNAG COMMENTS |
|---|---|---|---|---|
| 105 | Bedroom 1 | Electric Switch | | Improper termination - Gaps. |

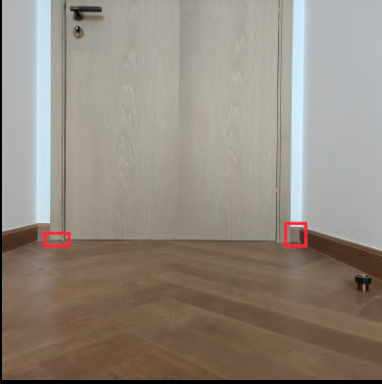
| SI NO | LOCATION | TRADE | PICTURE | SNAG COMMENTS |
|---|---|---|---|---|
| 106 | Bedroom 1 | Door & Frame | | Missing silicone at frame bottom termination - Gaps. |

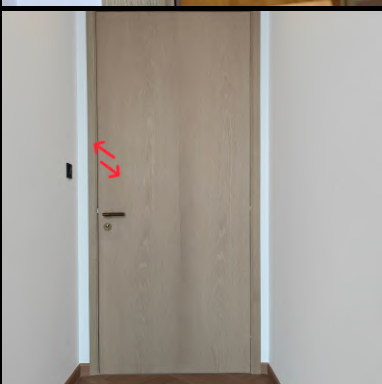
| SI NO | LOCATION | TRADE | PICTURE | SNAG COMMENTS |
|---|---|---|---|---|
| 108 | Bedroom 1 | Door & Frame | | Rattling doors. |

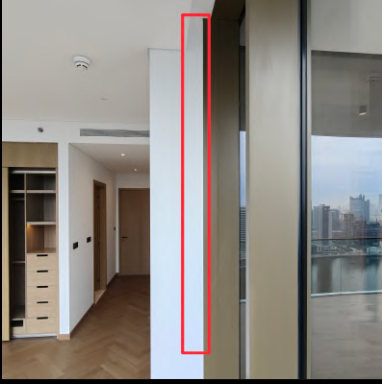
| SI NO | LOCATION | TRADE | PICTURE | SNAG COMMENTS |
|---|---|---|---|---|
| 110 | Bedroom 1 | Wall | | Uneven surface & cracks. |

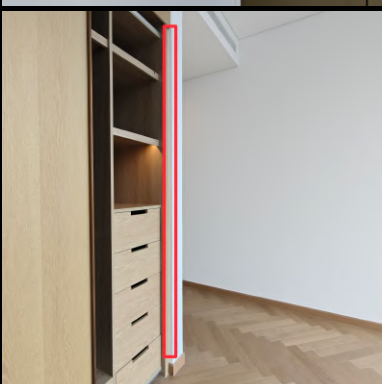
| SI NO | LOCATION | TRADE | PICTURE | SNAG COMMENTS |
|---|---|---|---|---|
| 111 | Bedroom 1 | Wall | | Uneven surface & poor finishing. |

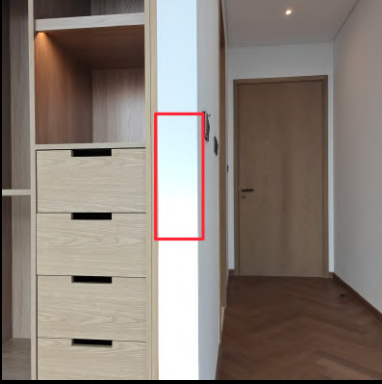
| SI NO | LOCATION | TRADE | PICTURE | SNAG COMMENTS |
|---|---|---|---|---|
| 112 | Bedroom 1 | Wall | | Stains & marks. |

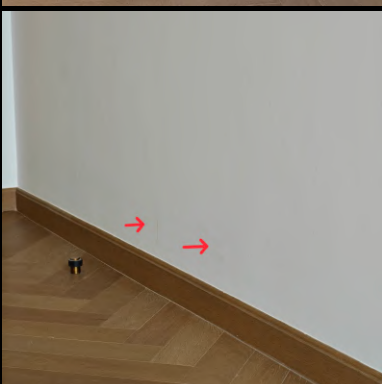
| SI NO | LOCATION | TRADE | PICTURE | SNAG COMMENTS |
|---|---|---|---|---|
| 115 | Bedroom 1 | Wall | | Stains & marks. |

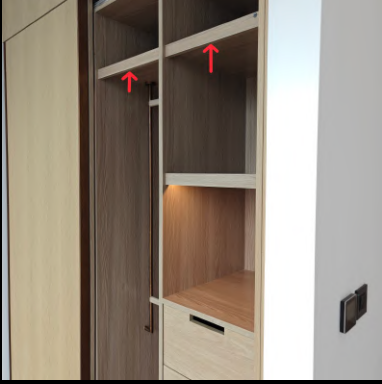
| SI NO | LOCATION | TRADE | PICTURE | SNAG COMMENTS |
|---|---|---|---|---|
| 117 | Bedroom 1 | Wardrobe | | Strip Lights are not functioning. |

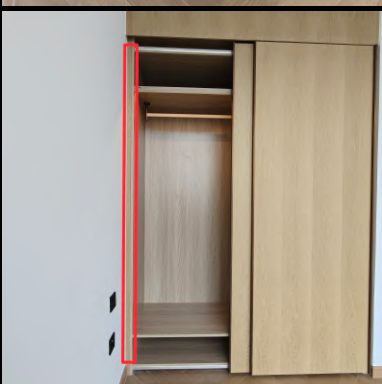
| SI NO | LOCATION | TRADE | PICTURE | SNAG COMMENTS |
|---|---|---|---|---|
| 120 | Bedroom 1 | Wardrobe | | Gaps between panel joints. |

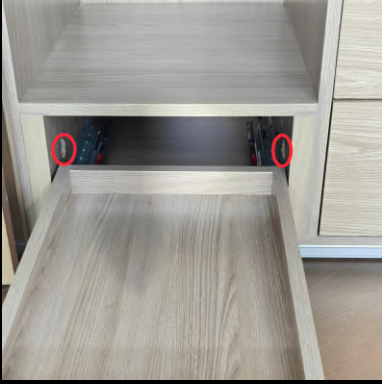
| SI NO | LOCATION | TRADE | PICTURE | SNAG COMMENTS |
|---|---|---|---|---|
| 121 | Bedroom 1 | Wardrobe | | Improper hole patch finishing. |

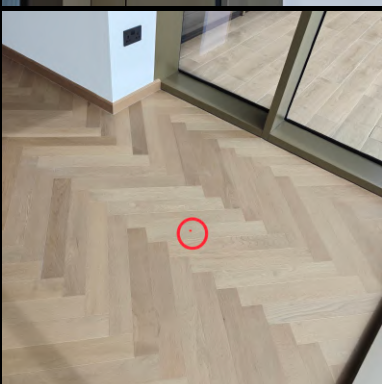
| SI NO | LOCATION | TRADE | PICTURE | SNAG COMMENTS |
|---|---|---|---|---|
| 124 | Bedroom 1 | Wooden Flooring | | Scratches. |

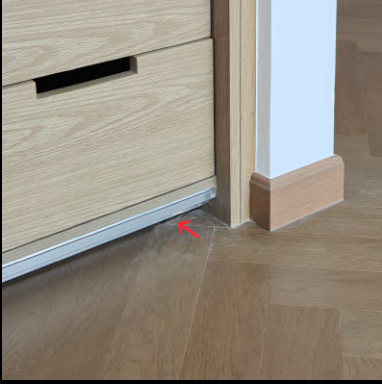
| SI NO | LOCATION | TRADE | PICTURE | SNAG COMMENTS |
|---|---|---|---|---|
| 126 | Bedroom 1 | Wooden Flooring | | Gaps at end termination. |

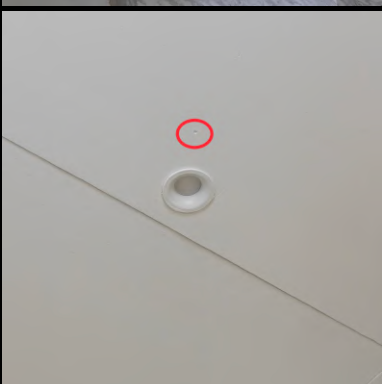
| SI NO | LOCATION | TRADE | PICTURE | SNAG COMMENTS |
|---|---|---|---|---|
| 129 | Washroom 1 | Ceiling | | Holes on surface. |

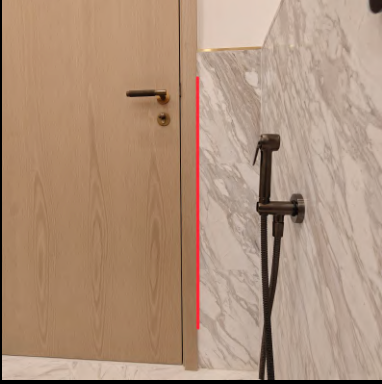
| SI NO | LOCATION | TRADE | PICTURE | SNAG COMMENTS |
|---|---|---|---|---|
| 131 | Washroom 1 | Door & Frame | | Improper termination - gaps observed. Missing silicone. |

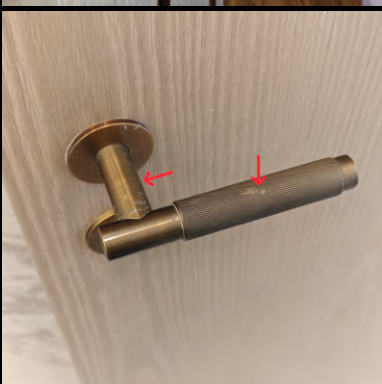
| SI NO | LOCATION | TRADE | PICTURE | SNAG COMMENTS |
|---|---|---|---|---|
| 133 | Washroom 1 | Door & Frame | | Polish damages. |

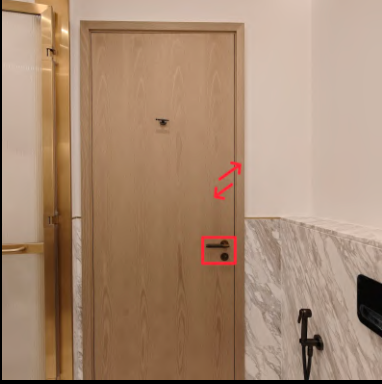
| SI NO | LOCATION | TRADE | PICTURE | SNAG COMMENTS |
|---|---|---|---|---|
| 135 | Washroom 1 | Door & Frame | | Rattling doors. Paint/polish damages on door handle. |

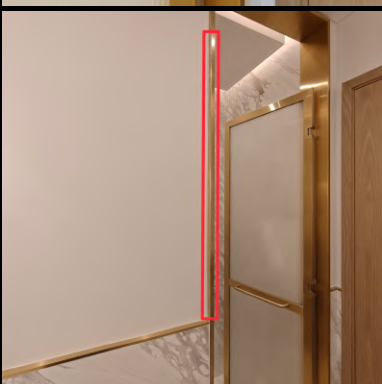
| SI NO | LOCATION | TRADE | PICTURE | SNAG COMMENTS |
|---|---|---|---|---|
| 137 | Washroom 1 | Aluminium Door & Frame | | Stains on frame. |

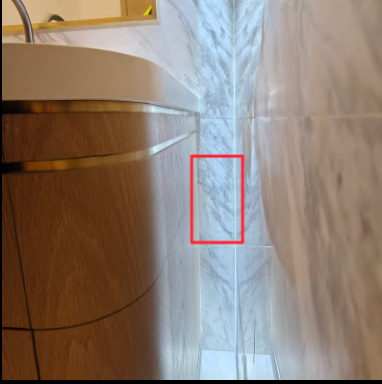
| SI NO | LOCATION | TRADE | PICTURE | SNAG COMMENTS |
|---|---|---|---|---|
| 142 | Washroom 1 | Wall Marbles | | Improper crack rectification observed. |

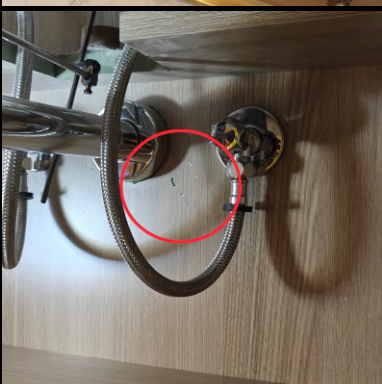
| SI NO | LOCATION | TRADE | PICTURE | SNAG COMMENTS |
|---|---|---|---|---|
| 145 | Washroom 1 | Vanity Cabinet | | Chipped panel surface. |

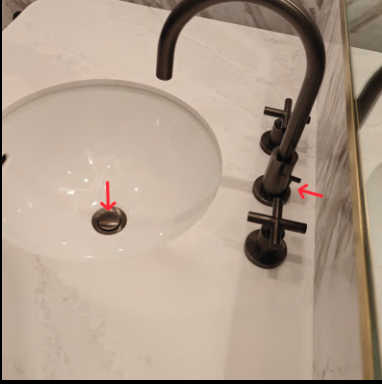
| SI NO | LOCATION | TRADE | PICTURE | SNAG COMMENTS |
|---|---|---|---|---|
| 147 | Washroom 1 | Washbasin | | Improper functioning of basin stoppers. |

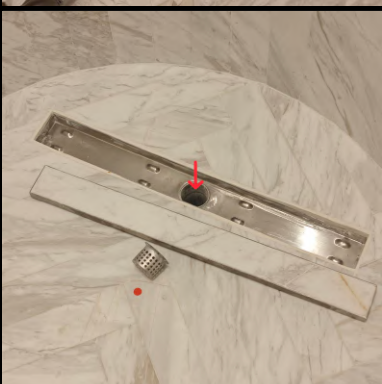
| SI NO | LOCATION | TRADE | PICTURE | SNAG COMMENTS |
|---|---|---|---|---|
| 150 | Washroom 1 | Shower Drain | | Dust & debris inside the drain to be cleaned. |

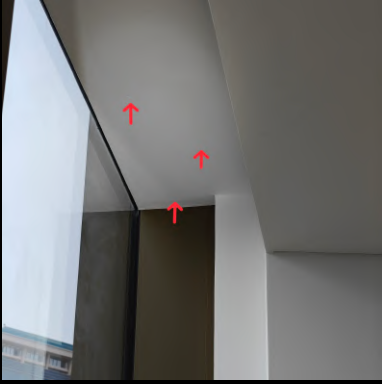
| SI NO | LOCATION | TRADE | PICTURE | SNAG COMMENTS |
|---|---|---|---|---|
| 152 | Master Bedroom | Ceiling | | Uneven & chipped surface. |

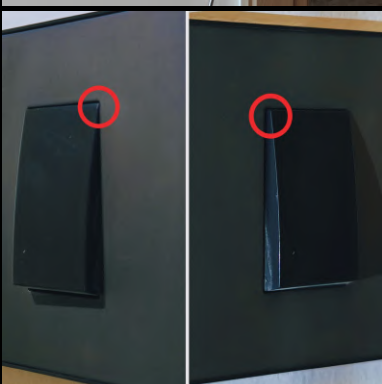
| SI NO | LOCATION | TRADE | PICTURE | SNAG COMMENTS |
|---|---|---|---|---|
| 154 | Master Bedroom | Electric Switch | | Switch button appears tilted in its installation. Proper alignment and fixing are recommended. |

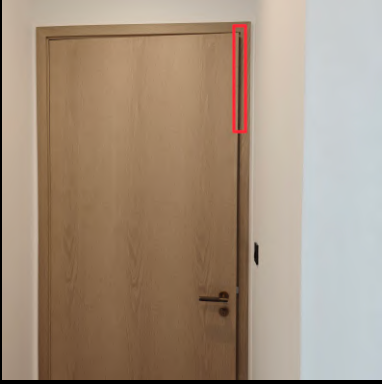
| SI NO | LOCATION | TRADE | PICTURE | SNAG COMMENTS |
|---|---|---|---|---|
| 156 | Master Bedroom | Door & Frame | | Misaligned doors touch the frame while opening & closing. |

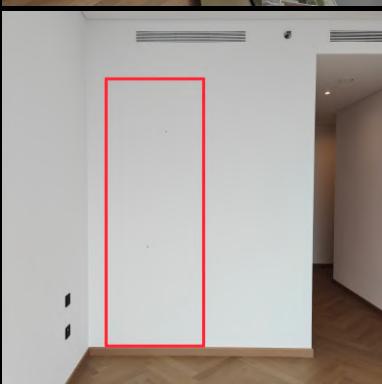
| SI NO | LOCATION | TRADE | PICTURE | SNAG COMMENTS |
|---|---|---|---|---|
| 159 | Master Bedroom | Wall | | Cracks on wall. |

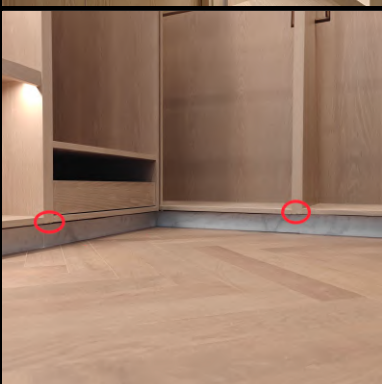
| SI NO | LOCATION | TRADE | PICTURE | SNAG COMMENTS |
|---|---|---|---|---|
| 164 | Master Dressing | Wardrobe | | Improper edge finishing. |

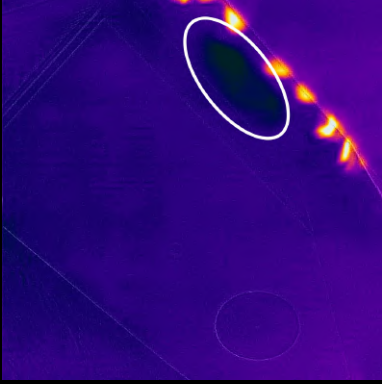
| SI NO | LOCATION | TRADE | PICTURE | SNAG COMMENTS |
|---|---|---|---|---|
| 166 | Master Washroom | MEP | | Moisture detected above ceiling, possibly from plumbing leak or condensation from FCU components. |

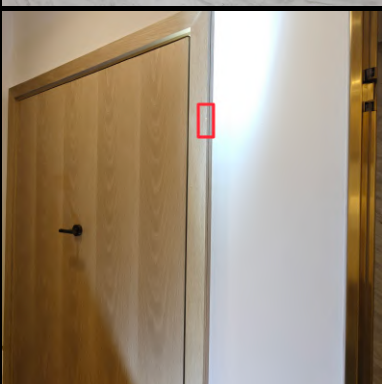
| SI NO | LOCATION | TRADE | PICTURE | SNAG COMMENTS |
|---|---|---|---|---|
| 168 | Master Washroom | Door & Frame | | Chipped/Damaged frame edges. |
