**PROPERTY NINJA**  
BUILDING INSPECTION

# WELCOME TO YOUR PROPERTY NINJA REPORT

**PROPERTY ADDRESS:** X X X X X X , Dubai.

During Snagging Property Ninja noticed **234 Snag** Issues to be rectified for **App X X X X X X , Dubai.**

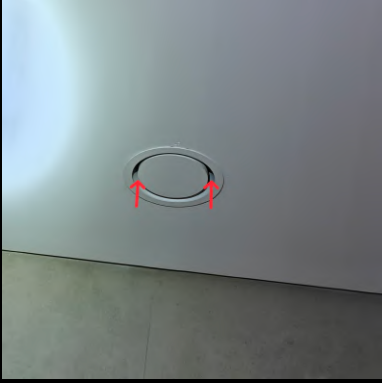
| SI NO | LOCATION | TRADE | PICTURE | SNAG COMMENTS |
|---|---|---|---|---|
| ✓ | General & Common Issues | Exhaust System | | ✓<br>Toilet and kitchen exhaust systems are operating effectively, providing adequate airflow and ventilation. Performance is within the expected range and considered acceptable. |

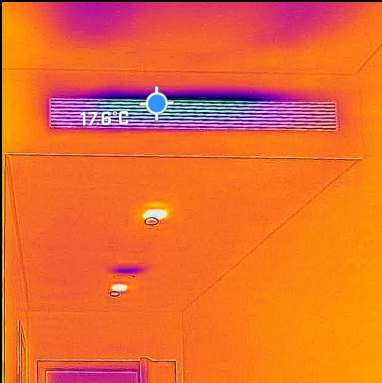
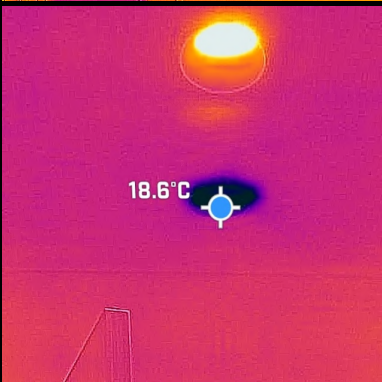
| SI NO | LOCATION | TRADE | PICTURE | SNAG COMMENTS |
|---|---|---|---|---|
| 2 | General & Common Issues | AC Cooling | | AC system is not cooling effectively, and the grill temperature is not being reached as expected throughout the apartment. Further inspection and servicing are recommended. |

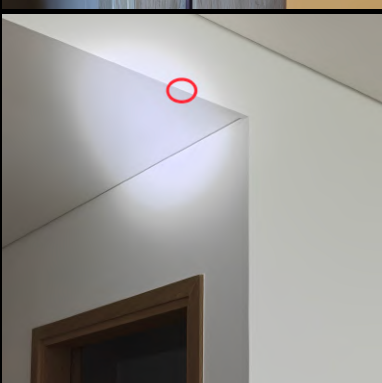
| SI NO | LOCATION | TRADE | PICTURE | SNAG COMMENTS |
|---|---|---|---|---|
| 4 | Entrance | Ceiling | | Chipped edges. |

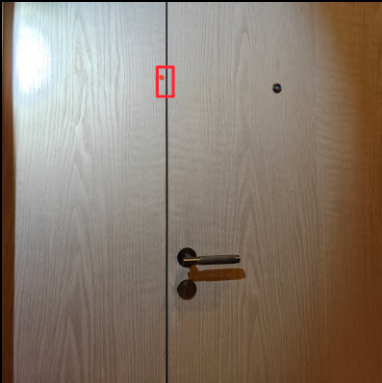
| SI NO | LOCATION | TRADE | PICTURE | SNAG COMMENTS |
|---|---|---|---|---|
| 6 | Entrance | Main Door & Frame | | Chipped edges. |

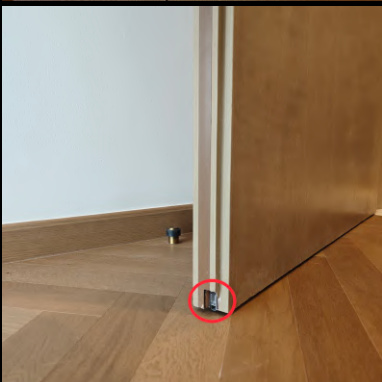
| SI NO | LOCATION | TRADE | PICTURE | SNAG COMMENTS |
|---|---|---|---|---|
| 7 | Entrance | Main Door & Frame | | Missing end pieces. |

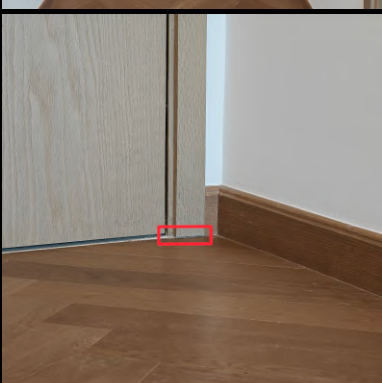
| SI NO | LOCATION | TRADE | PICTURE | SNAG COMMENTS |
|---|---|---|---|---|
| | Entrance | Main Door & Frame | | Missing silicone at frame bottom termination - Gaps. |

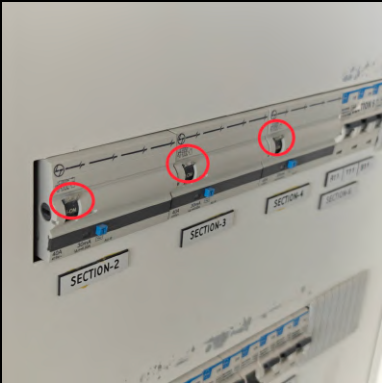
| SI NO | LOCATION | TRADE | PICTURE | SNAG COMMENTS |
|---|---|---|---|---|
| 9 | Entrance | Electric DB | | Trip handles of the RCCB are broken and need to be replaced to ensure proper safety operation. |

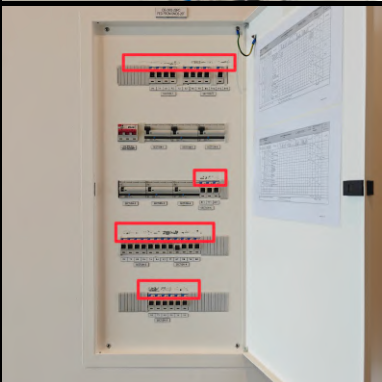
| SI NO | LOCATION | TRADE | PICTURE | SNAG COMMENTS |
|---|---|---|---|---|
| 10 | Entrance | Electric DB | | Paint damages. |

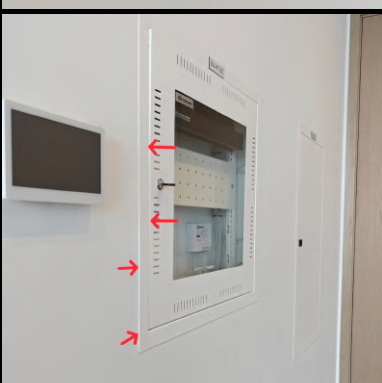
| SI NO | LOCATION | TRADE | PICTURE | SNAG COMMENTS |
|---|---|---|---|---|
| 11 | Entrance | ONU Cabinet | | Misaligned door rub the frame while opening/closing. Improve finishing between frame & wall termination - Gaps. |

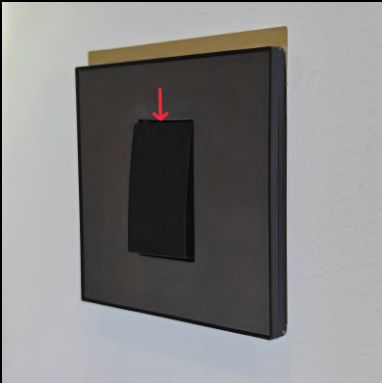
| SI NO | LOCATION | TRADE | PICTURE | SNAG COMMENTS |
|---|---|---|---|---|
| 12 | Entrance | Electric Switch | | Switch button appears tilted in its installation. Proper alignment and fixing are recommended. |

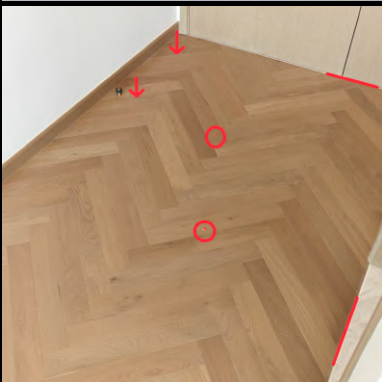
| SI NO | LOCATION | TRADE | PICTURE | SNAG COMMENTS |
|---|---|---|---|---|
| 13 | Entrance | Wooden Flooring | | Chipped surface & scratches. Gaps between wooden flooring & threshold termination. |

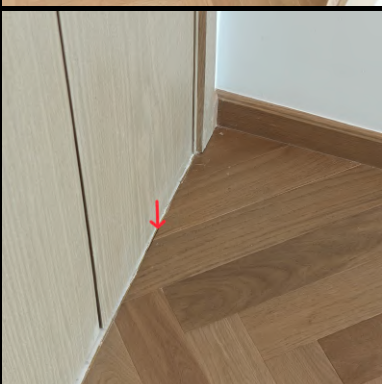
| SI NO | LOCATION | TRADE | PICTURE | SNAG COMMENTS |
|---|---|---|---|---|
| | Entrance | Wooden Flooring | | Gaps between wooden flooring & threshold termination. |

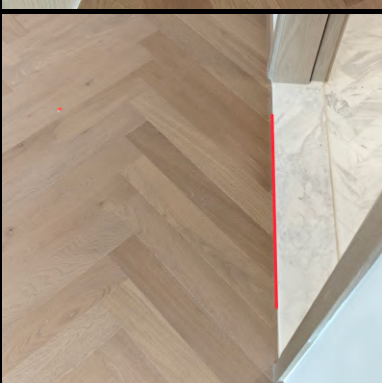
| SI NO | LOCATION | TRADE | PICTURE | SNAG COMMENTS |
|---|---|---|---|---|
| | Entrance | Wooden Flooring | | Gaps between wooden flooring & threshold termination. |

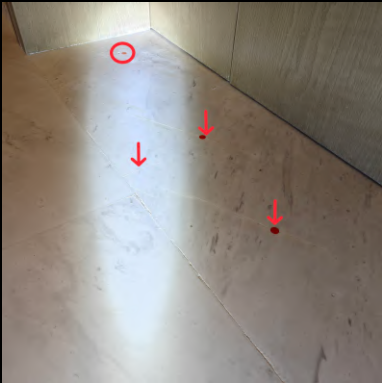
| SI NO | LOCATION | TRADE | PICTURE | SNAG COMMENTS |
|---|---|---|---|---|
| 16 | Entrance | Floor Threshold | | Chipped surface & cracks<br>- Improper rectification. |

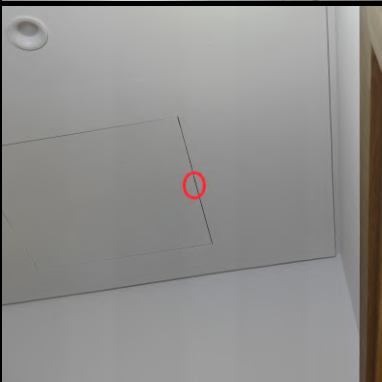
| SI NO | LOCATION | TRADE | PICTURE | SNAG COMMENTS |
|---|---|---|---|---|
| 17 | Powder Room | Ceiling | | Chipped edges. |

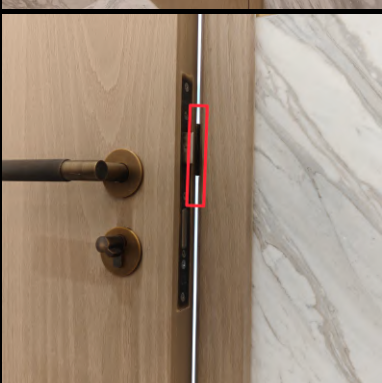
| SI NO | LOCATION | TRADE | PICTURE | SNAG COMMENTS |
|---|---|---|---|---|
| 19 | Powder Room | Door & Frame | | Misaligned door rub the frame while opening/closing. |

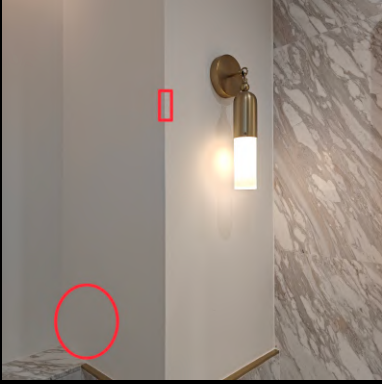
| SI NO | LOCATION | TRADE | PICTURE | SNAG COMMENTS |
|---|---|---|---|---|
| 20 | Powder Room | Wall | | Chipped wall edges & engraved scratches. |

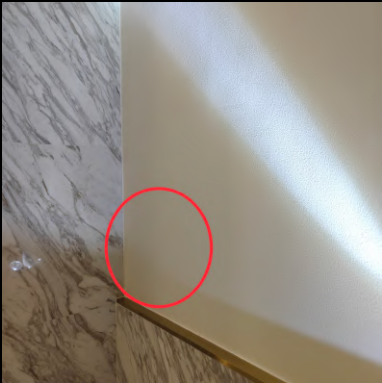
| SI NO | LOCATION | TRADE | PICTURE | SNAG COMMENTS |
|---|---|---|---|---|
| | Powder Room | Wall | | Engraved scratches. |

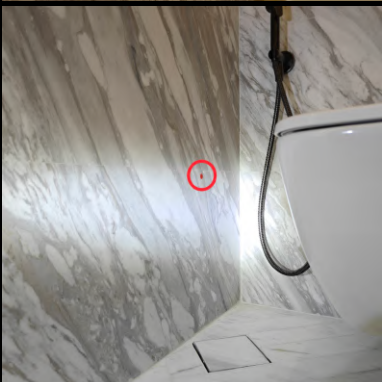
| SI NO | LOCATION | TRADE | PICTURE | SNAG COMMENTS |
|---|---|---|---|---|
| 21 | Powder Room | Wall Marbles | | Chipped marble surface. |

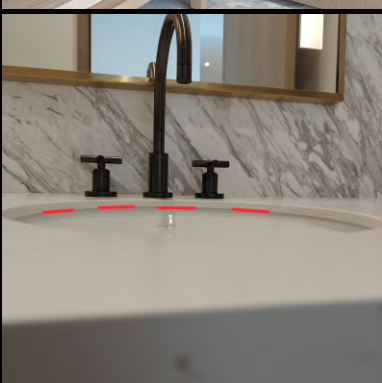
| SI NO | LOCATION | TRADE | PICTURE | SNAG COMMENTS |
|---|---|---|---|---|
| 23 | Powder Room | Washbasin | | Inconsistent/Missing silicone between basin & countertop termination. |

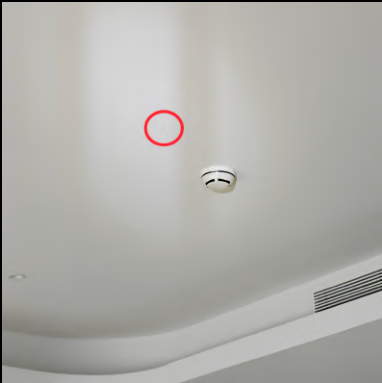
| SI NO | LOCATION | TRADE | PICTURE | SNAG COMMENTS |
|---|---|---|---|---|
| 25 | Living | Ceiling | | Stains & marks. |

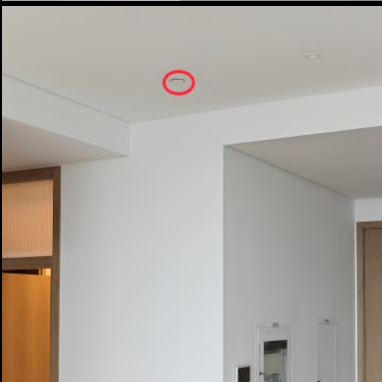
| SI NO | LOCATION | TRADE | PICTURE | SNAG COMMENTS |
|---|---|---|---|---|
| 26 | Living | Fire Sprinkler | | Improper termination of sprinkler cap - Gaps. |

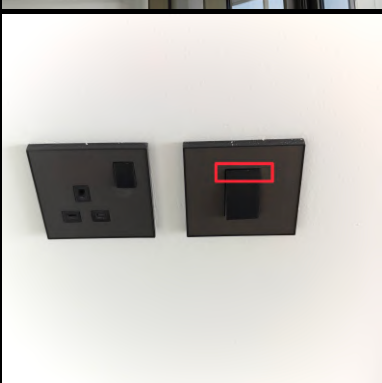
| SI NO | LOCATION | TRADE | PICTURE | SNAG COMMENTS |
|---|---|---|---|---|
| 28 | Living | Electric Switch | | Switch button appears tilted in its installation. Proper alignment and fixing are recommended. |

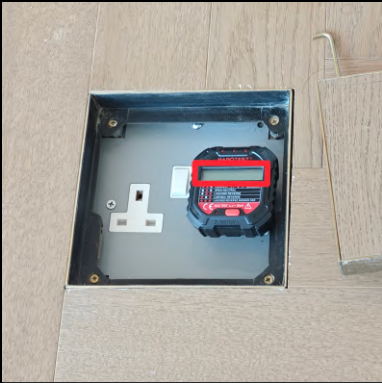
| SI NO | LOCATION | TRADE | PICTURE | SNAG COMMENTS |
|---|---|---|---|---|
| 29 | Living | Floor Electric Socket | | No power supply in electric sockets. |

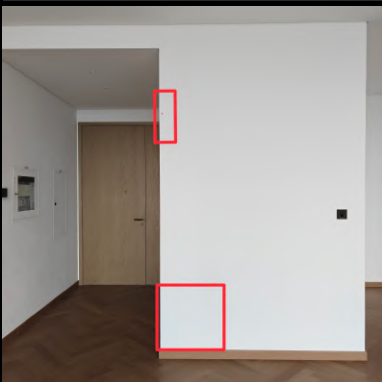
| SI NO | LOCATION | TRADE | PICTURE | SNAG COMMENTS |
|---|---|---|---|---|
| 30 | Living | Wall | | Stains & chipped surface. |

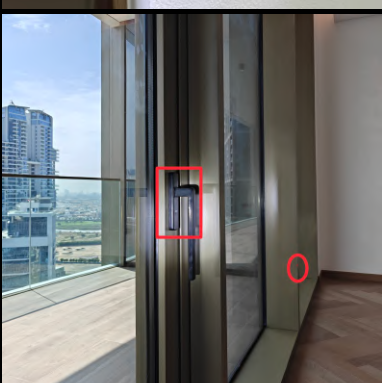
| SI NO | LOCATION | TRADE | PICTURE | SNAG COMMENTS |
|---|---|---|---|---|
| 31 | Living | Sliding Glass Door | | Loosely fit door handles.<br>Chipped/Paint damages at frame edges. |

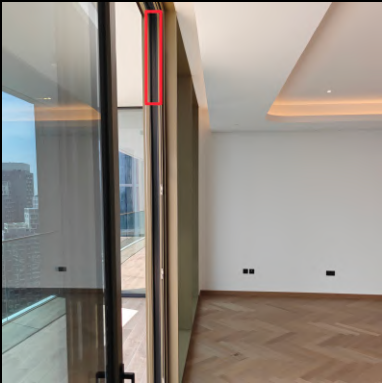
| SI NO | LOCATION | TRADE | PICTURE | SNAG COMMENTS |
|---|---|---|---|---|
| 33 | Living | Sliding Glass Door | | Noticeable scratches on frame. |

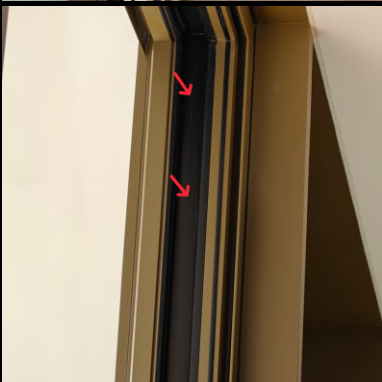
| SI NO | LOCATION | TRADE | PICTURE | SNAG COMMENTS |
|---|---|---|---|---|
| | Living | Sliding Glass Door | | Noticeable scratches on frame. |

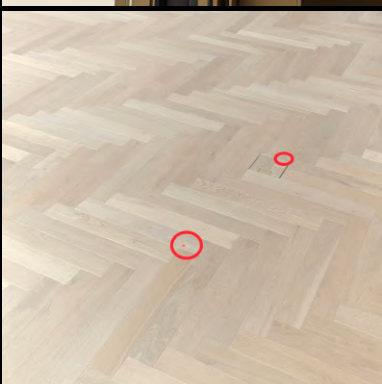
| SI NO | LOCATION | TRADE | PICTURE | SNAG COMMENTS |
|---|---|---|---|---|
| 35 | Living | Wooden Flooring | | Chipped surface & edges. |

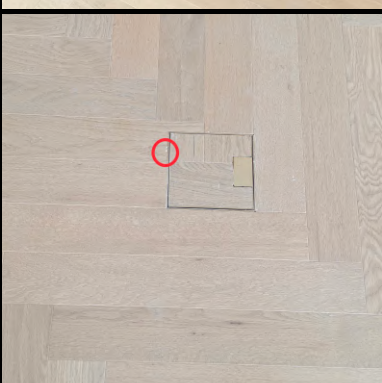
| SI NO | LOCATION | TRADE | PICTURE | SNAG COMMENTS |
|---|---|---|---|---|
| | Living | Wooden Flooring | | Chipped edges. |

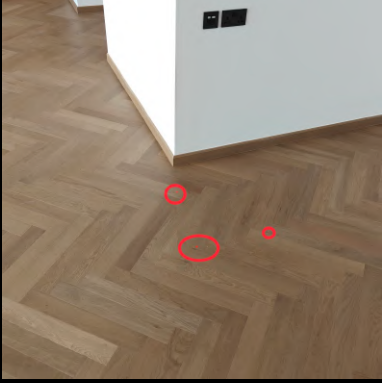
| SI NO | LOCATION | TRADE | PICTURE | SNAG COMMENTS |
|---|---|---|---|---|
| 37 | Living | Wooden Flooring | | Chipped/damaged surface. |

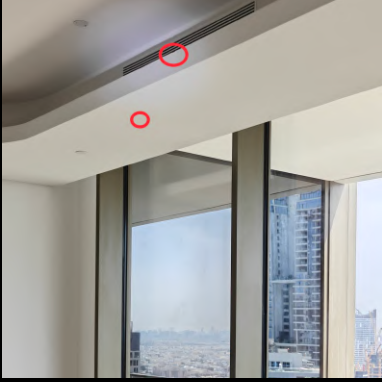
| SI NO | LOCATION | TRADE | PICTURE | SNAG COMMENTS |
|---|---|---|---|---|
| 38 | Dining | Ceiling | | Stains on surface & chipped edges. |

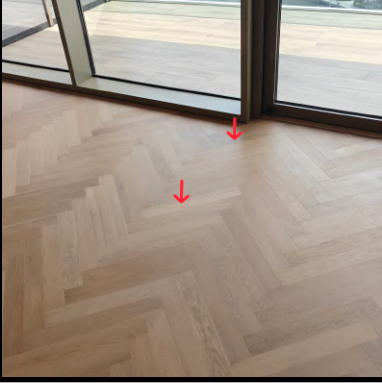
| SI NO | LOCATION | TRADE | PICTURE | SNAG COMMENTS |
|---|---|---|---|---|
| 40 | Dining | Wooden Flooring | | Noticeable scratches. |

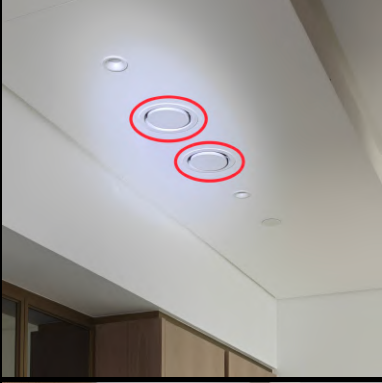
| SI NO | LOCATION | TRADE | PICTURE | SNAG COMMENTS |
|---|---|---|---|---|
| 42 | Show Kitchen | Ceiling | | Improve ceiling finishing around disc wall termination. |

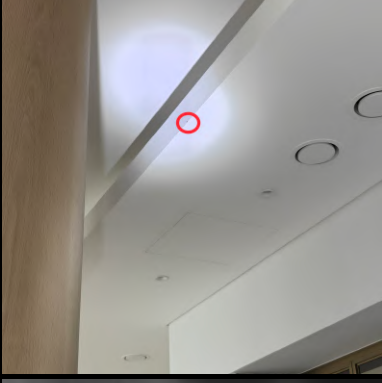
| SI NO | LOCATION | TRADE | PICTURE | SNAG COMMENTS |
|---|---|---|---|---|
| 43 | Show Kitchen | Ceiling | | Stains & marks. |

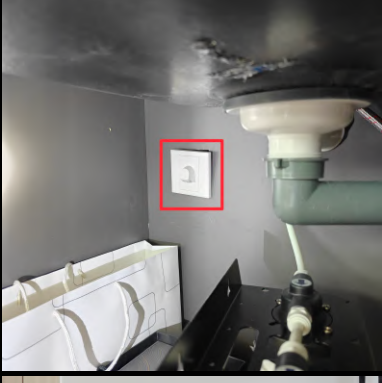
| SI NO | LOCATION | TRADE | PICTURE | SNAG COMMENTS |
|---|---|---|---|---|
| 44 | Show Kitchen | Electric Socket | | Broken sockets. |

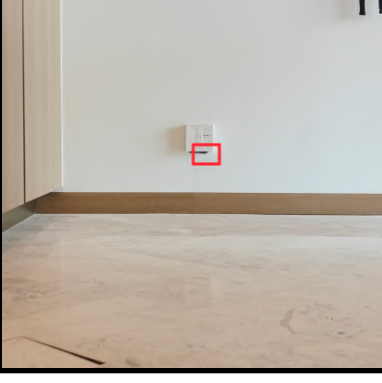
| SI NO | LOCATION | TRADE | PICTURE | SNAG COMMENTS |
|---|---|---|---|---|
| 45 | Show Kitchen | Wall | | Chipped wall surface. |

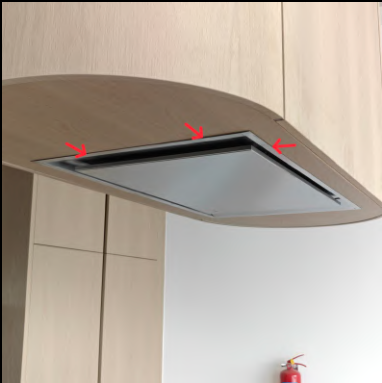
| SI NO | LOCATION | TRADE | PICTURE | SNAG COMMENTS |
|---|---|---|---|---|
| 47 | Show Kitchen | Kitchen Hood | | Improper termination - gaps observed. |

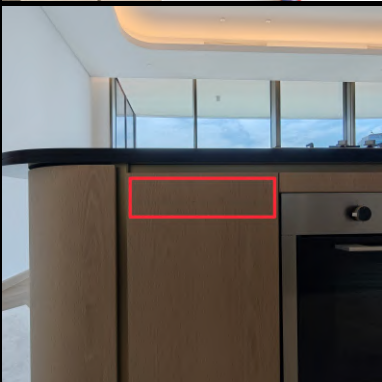
| SI NO | LOCATION | TRADE | PICTURE | SNAG COMMENTS |
|---|---|---|---|---|
| 48 | Show Kitchen | Cabinet | | Stains & marks. |

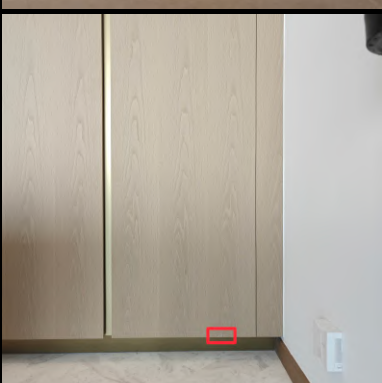
| SI NO | LOCATION | TRADE | PICTURE | SNAG COMMENTS |
|---|---|---|---|---|
| 50 | Show Kitchen | Cabinet | | Scratches & damages. |

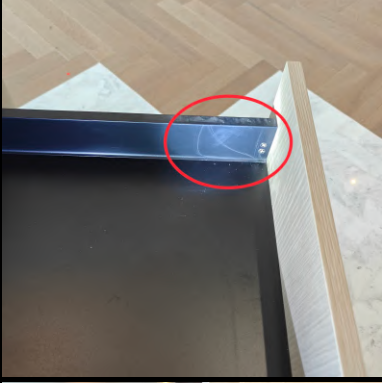
| SI NO | LOCATION | TRADE | PICTURE | SNAG COMMENTS |
|---|---|---|---|---|
| | Show Kitchen | Cabinet | | Multiple scratches on drawer surface. |

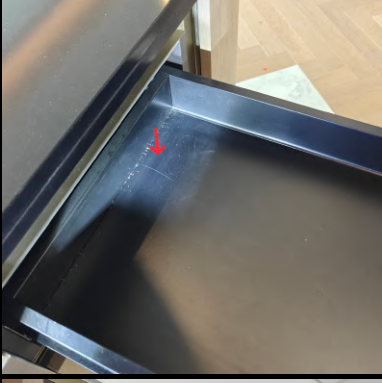
| SI NO | LOCATION | TRADE | PICTURE | SNAG COMMENTS |
|---|---|---|---|---|
| | Show Kitchen | Cabinet | | Multiple scratches on drawer surface. |

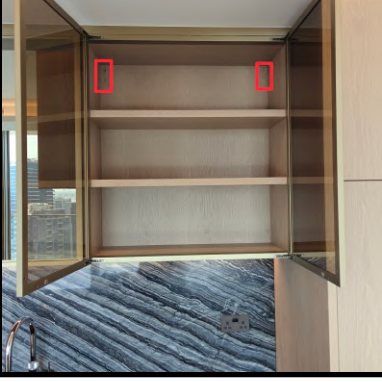
| SI NO | LOCATION | TRADE | PICTURE | SNAG COMMENTS |
|---|---|---|---|---|
| 53 | Show Kitchen | Cabinet | | Peeling off back panel screw hole dummy. |

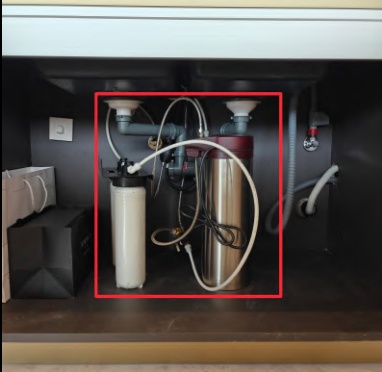
| SI NO | LOCATION | TRADE | PICTURE | SNAG COMMENTS |
|---|---|---|---|---|
| 55 | Show Kitchen | Water Filtration System | | Water filtration system was not functioning at the time of snagging. The developer/contractor should demonstrate the system operation & provide proper guidance at the time of handover or move-in. |

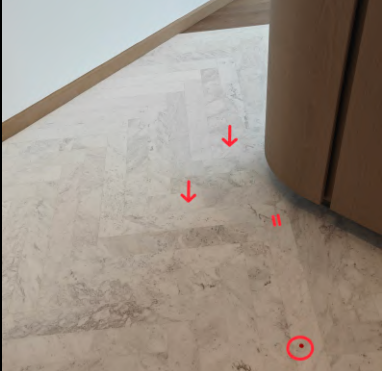
| SI NO | LOCATION | TRADE | PICTURE | SNAG COMMENTS |
|---|---|---|---|---|
| 56 | Show Kitchen | Floor Marbles | | Chipped, Unlevelled & scratches on marbles. |

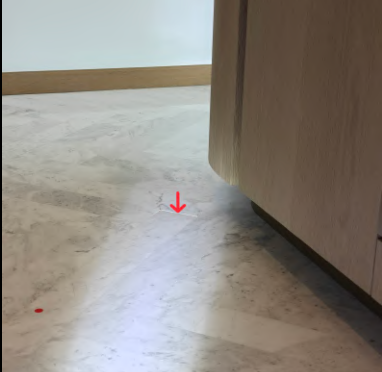
| SI NO | LOCATION | TRADE | PICTURE | SNAG COMMENTS |
|---|---|---|---|---|
| | Show Kitchen | Floor Marbles | | Unlevelled marbles. |

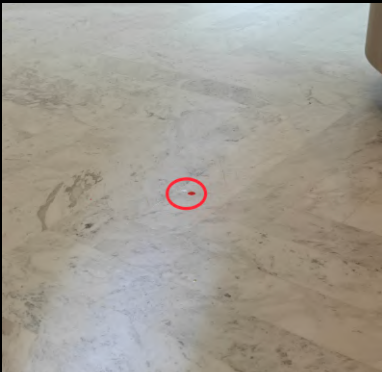
| SI NO | LOCATION | TRADE | PICTURE | SNAG COMMENTS |
|---|---|---|---|---|
| | Show Kitchen | Floor Marbles | | Chipped Marbles. |

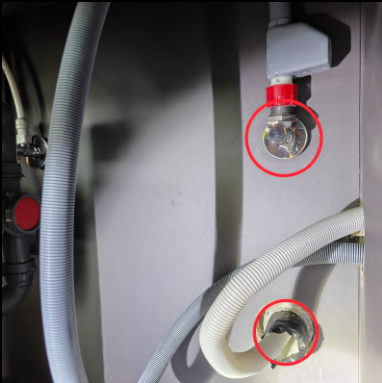
| SI NO | LOCATION | TRADE | PICTURE | SNAG COMMENTS |
|---|---|---|---|---|
| 58 | Show Kitchen | Dishwasher Piping | | Water leakage/seepage stains observed at inlet wall. Missing rubber bush around drain pipe termination. |

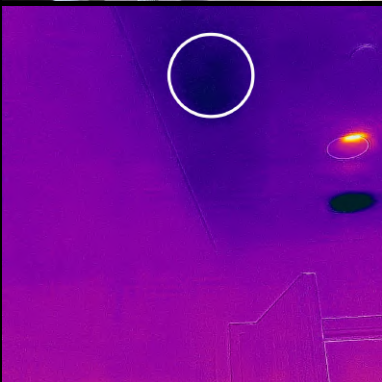
| SI NO | LOCATION | TRADE | PICTURE | SNAG COMMENTS |
|---|---|---|---|---|
| 59 | Back Kitchen & Laundry | MEP | | Moisture detected above ceiling, possibly from plumbing leak or condensation from FCU components. |

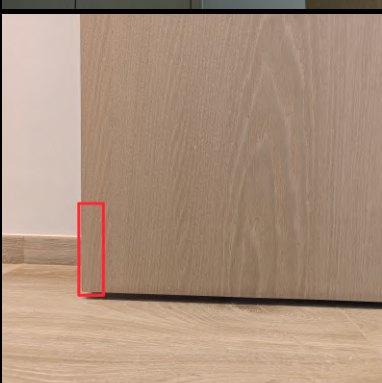
| SI NO | LOCATION | TRADE | PICTURE | SNAG COMMENTS |
|---|---|---|---|---|
| 62 | Back Kitchen & Laundry | Door & Frame | | Cracks. |

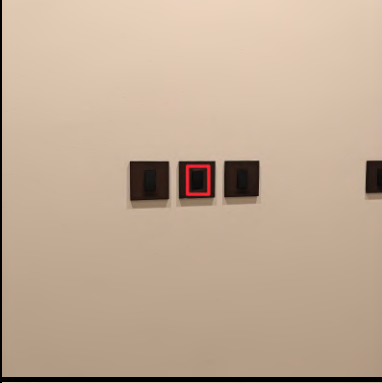
| SI NO | LOCATION | TRADE | PICTURE | SNAG COMMENTS |
|---|---|---|---|---|
| 64 | Back Kitchen & Laundry | Electric Switch | | Switch button appears tilted in its installation. Proper alignment and fixing are recommended. |

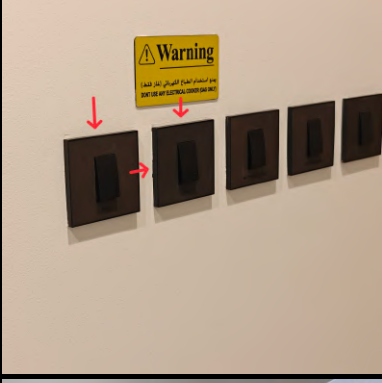
| SI NO | LOCATION | TRADE | PICTURE | SNAG COMMENTS |
|---|---|---|---|---|
| 65 | Back Kitchen & Laundry | Electric Switch | | Improve wall finishing around switches termination. |

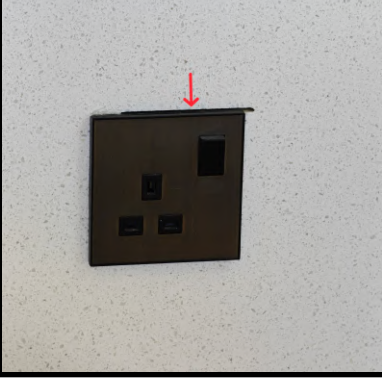
| SI NO | LOCATION | TRADE | PICTURE | SNAG COMMENTS |
|---|---|---|---|---|
| 66 | Back Kitchen & Laundry | Electric Socket | | Improper termination - Gaps. |

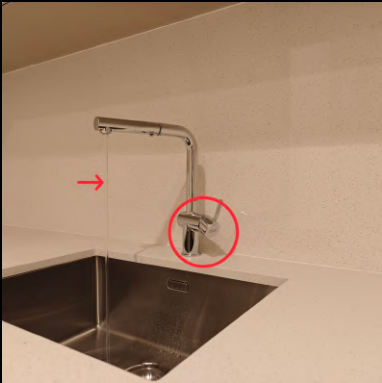
| SI NO | LOCATION | TRADE | PICTURE | SNAG COMMENTS |
|---|---|---|---|---|
| 68 | Back Kitchen & Laundry | Sink | | Loosely fit faucets. Low water pressure. |

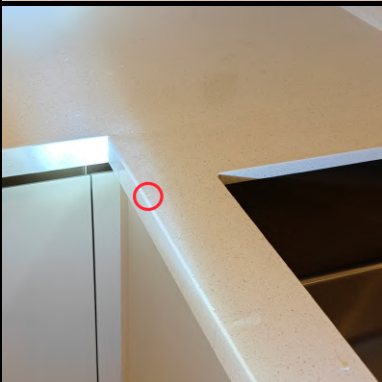
| SI NO | LOCATION | TRADE | PICTURE | SNAG COMMENTS |
|---|---|---|---|---|
| 69 | Back Kitchen & Laundry | Counter Top | | Chipped/damaged edges. |

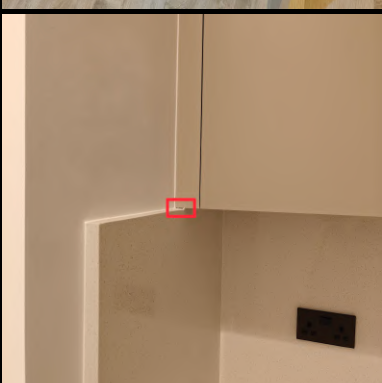
| SI NO | LOCATION | TRADE | PICTURE | SNAG COMMENTS |
|---|---|---|---|---|
| 71 | Back Kitchen & Laundry | Cabinet | | Missing silicone - Gaps. |

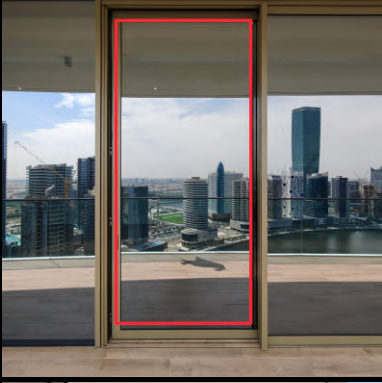
| SI NO | LOCATION | TRADE | PICTURE | SNAG COMMENTS |
|---|---|---|---|---|
| 73 | Balcony | Sliding Glass Door | | Scratches on glass panels. |

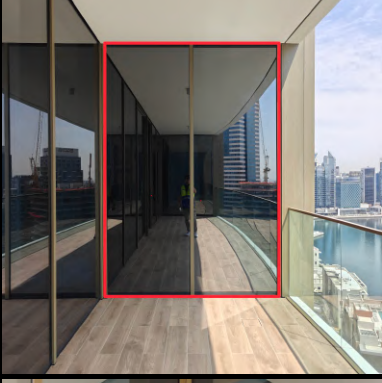
| SI NO | LOCATION | TRADE | PICTURE | SNAG COMMENTS |
|---|---|---|---|---|
| 74 | Balcony | Sliding Glass Door | | Scratches on glass panels. |

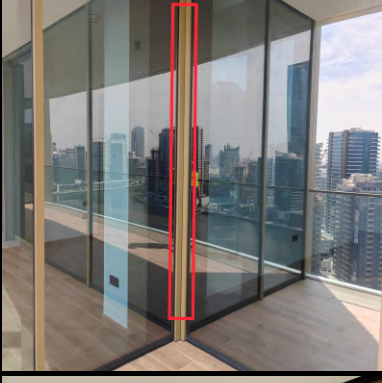
| SI NO | LOCATION | TRADE | PICTURE | SNAG COMMENTS |
|---|---|---|---|---|
| 75 | Balcony | Sliding Glass Door | | Dents & paint damages on frame. |

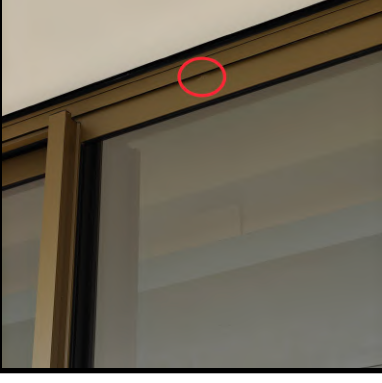
| SI NO | LOCATION | TRADE | PICTURE | SNAG COMMENTS |
|---|---|---|---|---|
| 76 | Balcony | Sliding Glass Door | | Stains/scratches/paint damages. |

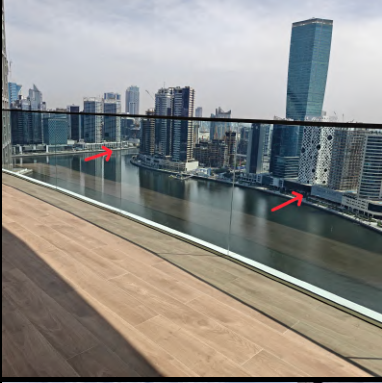
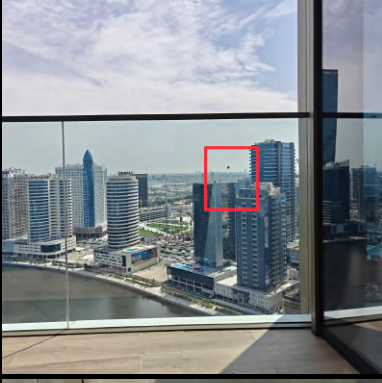
| SI NO | LOCATION | TRADE | PICTURE | SNAG COMMENTS |
|---|---|---|---|---|
| 78 | Balcony | Guardrail | | Stains & scratches on glass panels. |

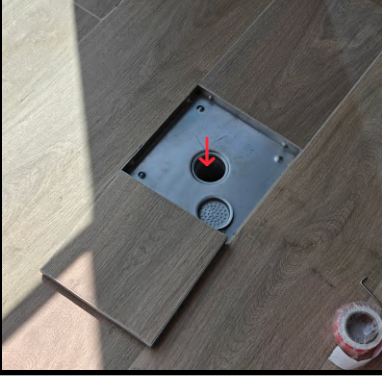
| SI NO | LOCATION | TRADE | PICTURE | SNAG COMMENTS |
|---|---|---|---|---|
| 80 | Balcony | Rain Water Drain | | Dust & debris - Drain to be cleaned. |

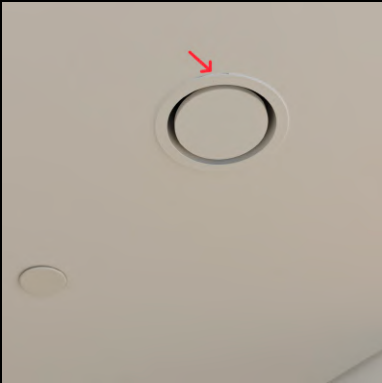
| SI NO | LOCATION | TRADE | PICTURE | SNAG COMMENTS |
|---|---|---|---|---|
| 82 | Passage | Disc Valve | | Improve finishing around disc valve termination. |

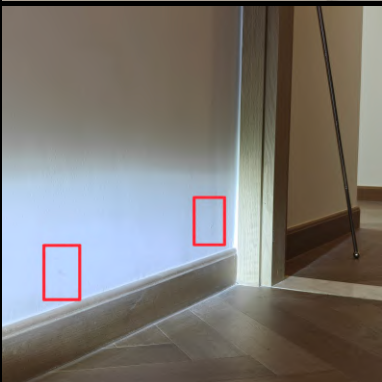
| SI NO | LOCATION | TRADE | PICTURE | SNAG COMMENTS |
|---|---|---|---|---|
| 83 | Passage | Wall | | Stains & blubs. |

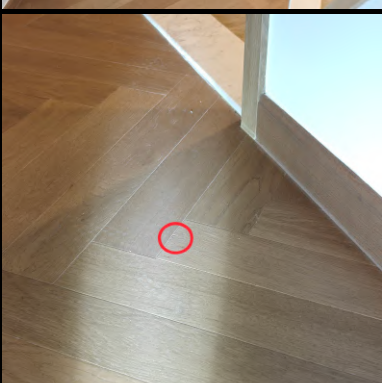
| SI NO | LOCATION | TRADE | PICTURE | SNAG COMMENTS |
|---|---|---|---|---|
| 85 | Passage | Wooden Flooring | | Chipped panel edges. |

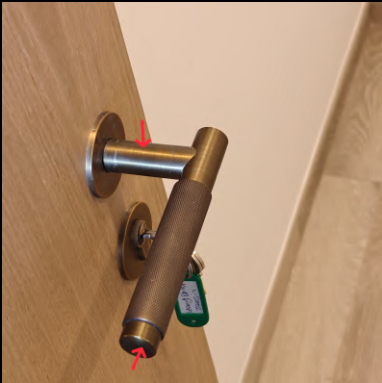
| SI NO | LOCATION | TRADE | PICTURE | SNAG COMMENTS |
|---|---|---|---|---|
| 87 | Maids Room | Door & Frame | | Paint & polish damages on door handle. |

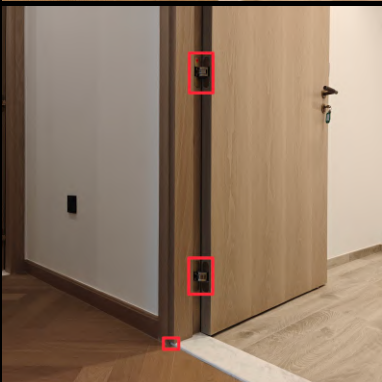
| SI NO | LOCATION | TRADE | PICTURE | SNAG COMMENTS |
|---|---|---|---|---|
| 88 | Maids Room | Door & Frame | | Gaps at frame bottom termination. Improper fitting of door hinge dummy. |

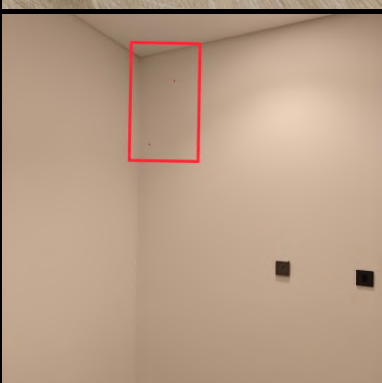
| SI NO | LOCATION | TRADE | PICTURE | SNAG COMMENTS |
|---|---|---|---|---|
| 90 | Maids Room | Wall | | Cracks on walls. |

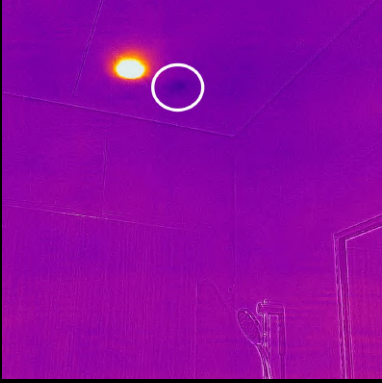
| SI NO | LOCATION | TRADE | PICTURE | SNAG COMMENTS |
|---|---|---|---|---|
| 92 | Maids Washroom | MEP | | Moisture detected above ceiling, possibly from plumbing leak or condensation from FCU components. |

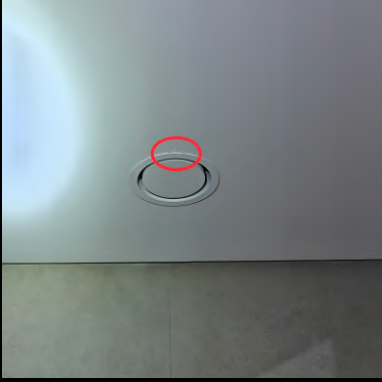
| SI NO | LOCATION | TRADE | PICTURE | SNAG COMMENTS |
|---|---|---|---|---|
| 93 | Maids Washroom | Ceiling | | Chipped surface & poor finishing around light termination. |

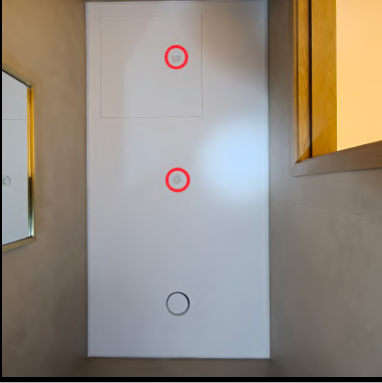
| SI NO | LOCATION | TRADE | PICTURE | SNAG COMMENTS |
|---|---|---|---|---|
| 95 | Maids Washroom | Electric Light | | Improper termination of spotlights - gaps & poor finishing. |

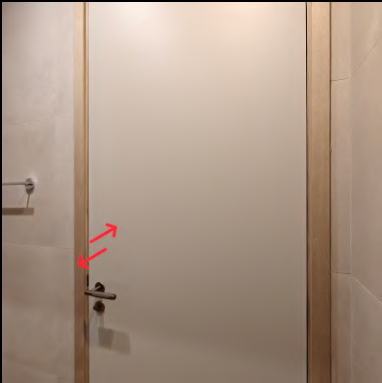
| SI NO | LOCATION | TRADE | PICTURE | SNAG COMMENTS |
|---|---|---|---|---|
| 97 | Maids Washroom | Door & Frame | | Rattling doors. |

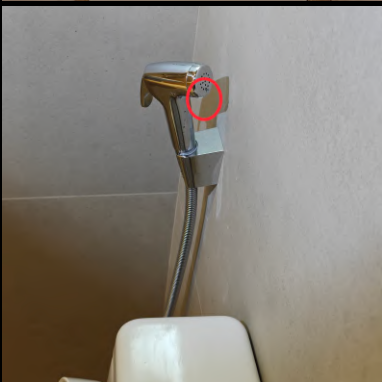
| SI NO | LOCATION | TRADE | PICTURE | SNAG COMMENTS |
|---|---|---|---|---|
| 98 | Maids Washroom | Toilet | | Water leakage from handspray head. |

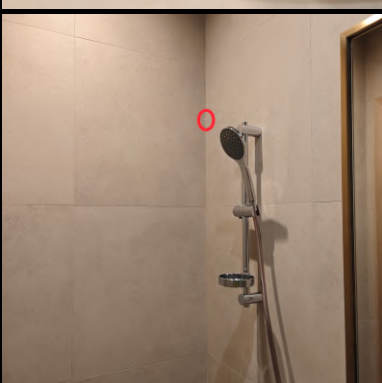
| SI NO | LOCATION | TRADE | PICTURE | SNAG COMMENTS |
|---|---|---|---|---|
| 100 | Maids Washroom | Wall Tiles | | Chipped tiles. |

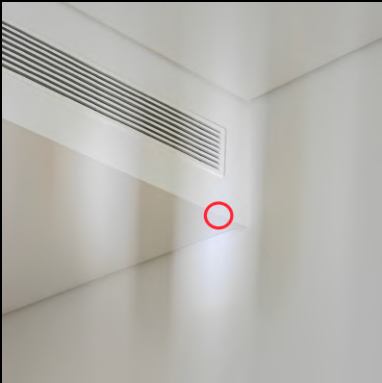
| SI NO | LOCATION | TRADE | PICTURE | SNAG COMMENTS |
|---|---|---|---|---|
| 102 | Bedroom 1 | Ceiling | | Chipped edges. |

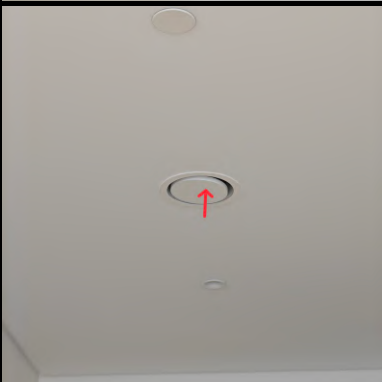
| SI NO | LOCATION | TRADE | PICTURE | SNAG COMMENTS |
|---|---|---|---|---|
| 103 | Bedroom 1 | AC Disc Valve | | Improper & tilted fittings. |

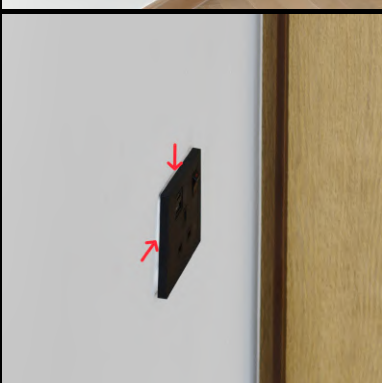
| SI NO | LOCATION | TRADE | PICTURE | SNAG COMMENTS |
|---|---|---|---|---|
| 105 | Bedroom 1 | Electric Switch | | Improper termination - Gaps. |

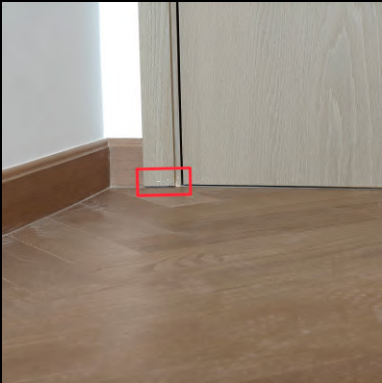
| SI NO | LOCATION | TRADE | PICTURE | SNAG COMMENTS |
|---|---|---|---|---|
| 106 | Bedroom 1 | Door & Frame | | Missing silicone at frame bottom termination - Gaps. |

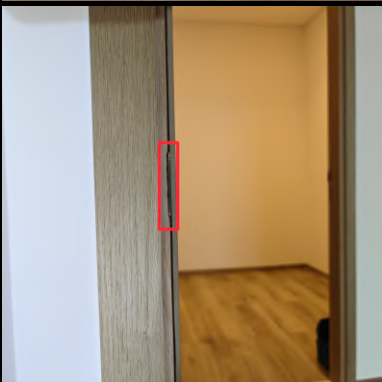
| SI NO | LOCATION | TRADE | PICTURE | SNAG COMMENTS |
|---|---|---|---|---|
| 107 | Bedroom 1 | Door & Frame | | Improve finishing behind striker plate. |

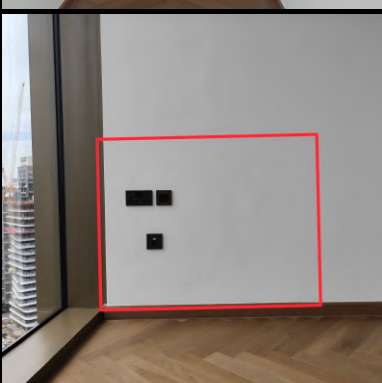
| SI NO | LOCATION | TRADE | PICTURE | SNAG COMMENTS |
|---|---|---|---|---|
| 109 | Bedroom 1 | Wall | | Stains, marks & uneven surface. |

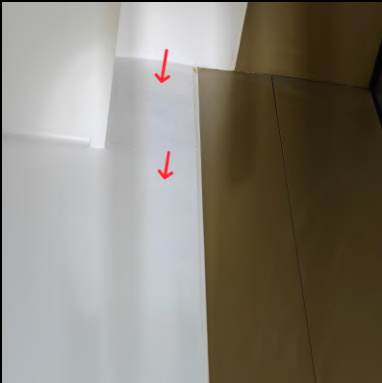
| SI NO | LOCATION | TRADE | PICTURE | SNAG COMMENTS |
|---|---|---|---|---|
| | Bedroom 1 | Wall | | Uneven surface. |

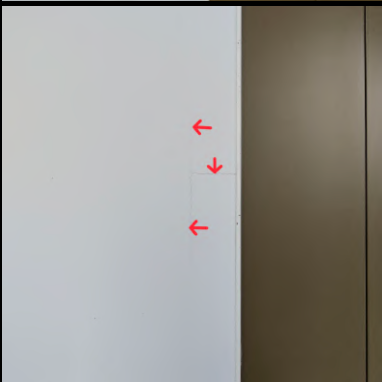
| SI NO | LOCATION | TRADE | PICTURE | SNAG COMMENTS |
|---|---|---|---|---|
| | Bedroom 1 | Wall | | Cracks. |

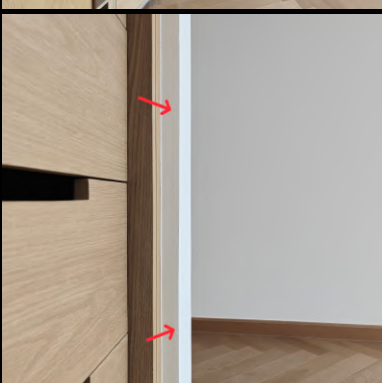
| SI NO | LOCATION | TRADE | PICTURE | SNAG COMMENTS |
|---|---|---|---|---|
| 111 | Bedroom 1 | Wall | | Uneven surface & poor finishing. |

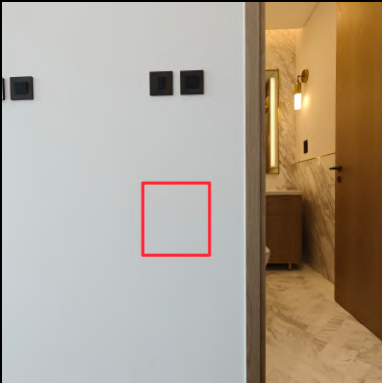
| SI NO | LOCATION | TRADE | PICTURE | SNAG COMMENTS |
|---|---|---|---|---|
| 113 | Bedroom 1 | Wall | | Stains & marks. |

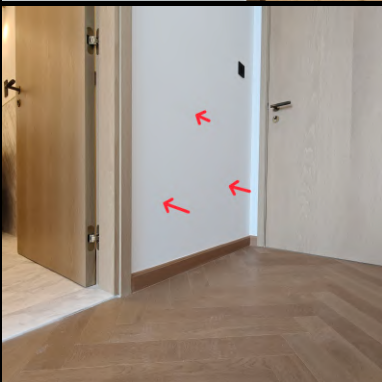
| SI NO | LOCATION | TRADE | PICTURE | SNAG COMMENTS |
|---|---|---|---|---|
| 114 | Bedroom 1 | Wall | | Stains & marks. |

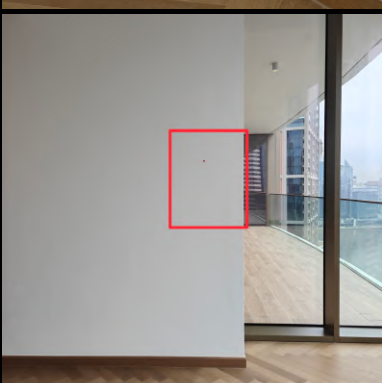
| SI NO | LOCATION | TRADE | PICTURE | SNAG COMMENTS |
|---|---|---|---|---|
| 116 | Bedroom 1 | Wall | | Stains & marks. |

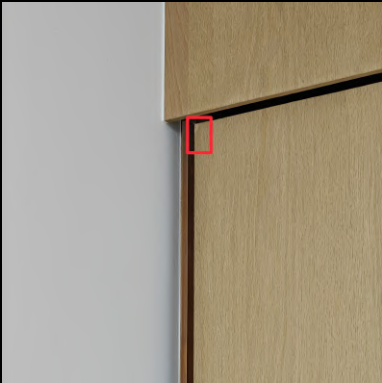
| SI NO | LOCATION | TRADE | PICTURE | SNAG COMMENTS |
|---|---|---|---|---|
| 118 | Bedroom 1 | Wardrobe | | Damaged edges. |

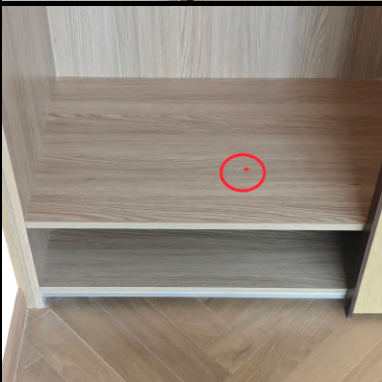
| SI NO | LOCATION | TRADE | PICTURE | SNAG COMMENTS |
|---|---|---|---|---|
| 119 | Bedroom 1 | Wardrobe | | Chipped surface. |

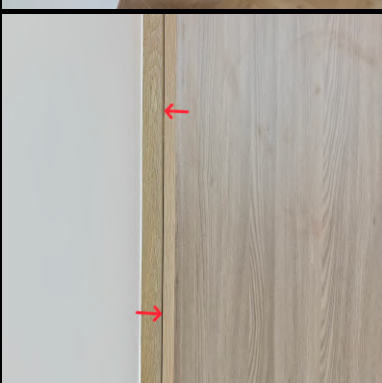
| SI NO | LOCATION | TRADE | PICTURE | SNAG COMMENTS |
|---|---|---|---|---|
| 120 | Bedroom 1 | Wardrobe | | Gaps between panel joints. |

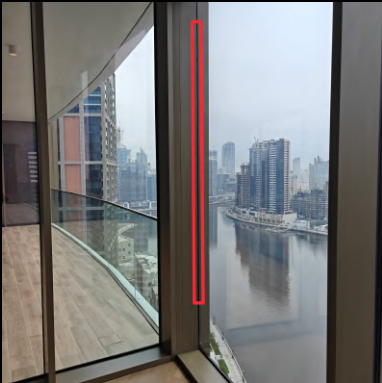
| SI NO | LOCATION | TRADE | PICTURE | SNAG COMMENTS |
|---|---|---|---|---|
| 122 | Bedroom 1 | Window | | Stained rubber seals to be cleaned. |

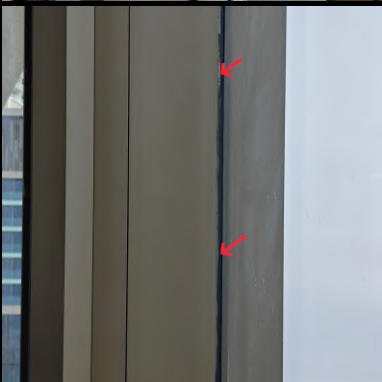
| SI NO | LOCATION | TRADE | PICTURE | SNAG COMMENTS |
|---|---|---|---|---|
| 123 | Bedroom 1 | Window | | Stained rubber seals to be cleaned. |

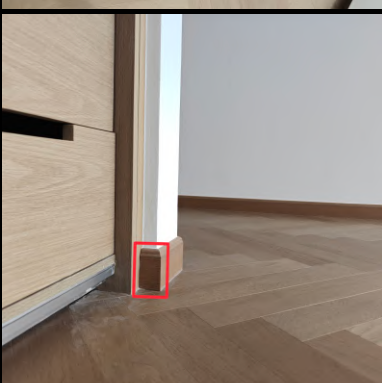
| SI NO | LOCATION | TRADE | PICTURE | SNAG COMMENTS |
|---|---|---|---|---|
| 125 | Bedroom 1 | Wooden Flooring | | Gaps at skirting end termination. |

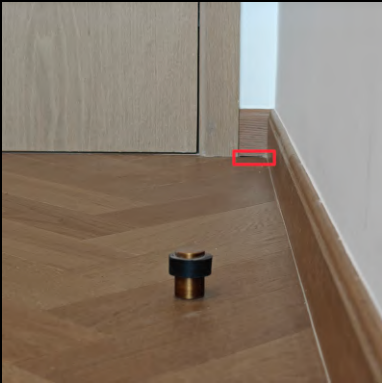
| SI NO | LOCATION | TRADE | PICTURE | SNAG COMMENTS |
|---|---|---|---|---|
| 127 | Bedroom 1 | Wooden Flooring | | Gaps at skirting bottom termination. |

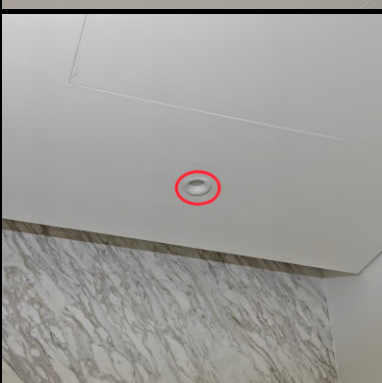
| SI NO | LOCATION | TRADE | PICTURE | SNAG COMMENTS |
|---|---|---|---|---|
| 130 | Washroom 1 | Electric Light | | Improve finishing around light termination. |

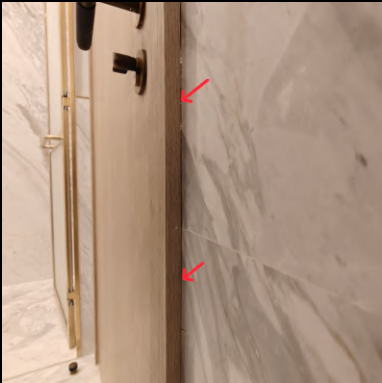
| SI NO | LOCATION | TRADE | PICTURE | SNAG COMMENTS |
|---|---|---|---|---|
| 131 | Washroom 1 | Door & Frame | | Improper termination - gaps observed. Missing silicone. |

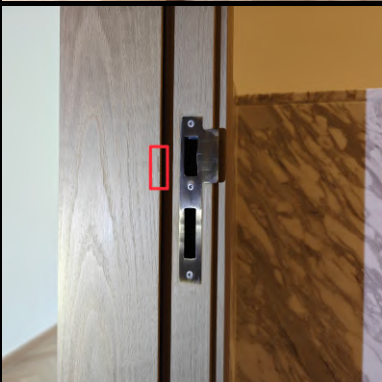
| SI NO | LOCATION | TRADE | PICTURE | SNAG COMMENTS |
|---|---|---|---|---|
| 132 | Washroom 1 | Door & Frame | | Chipped edges. |

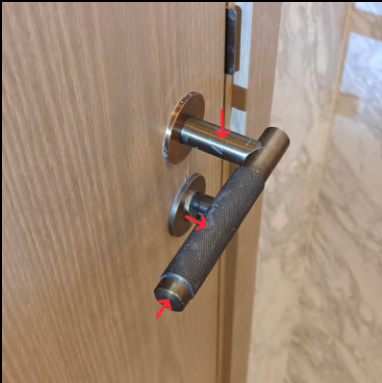
| SI NO | LOCATION | TRADE | PICTURE | SNAG COMMENTS |
|---|---|---|---|---|
| | Washroom 1 | Door & Frame | | Paint/polish damages on door handle. |

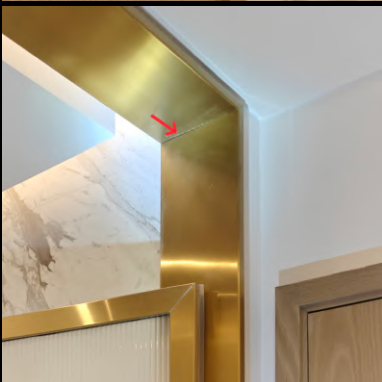
| SI NO | LOCATION | TRADE | PICTURE | SNAG COMMENTS |
|---|---|---|---|---|
| 136 | Washroom 1 | Aluminium Door & Frame | | Gaps at frame joints. |

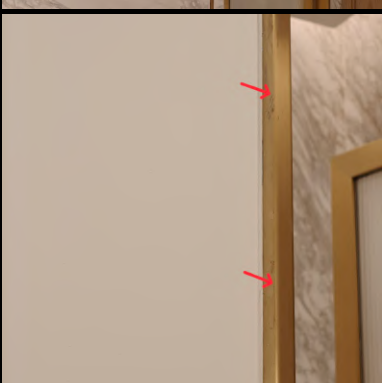
| SI NO | LOCATION | TRADE | PICTURE | SNAG COMMENTS |
|---|---|---|---|---|
| 137 | Washroom 1 | Aluminium Door & Frame | | Stains on frame. |

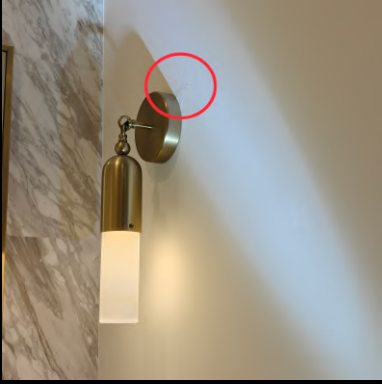
| SI NO | LOCATION | TRADE | PICTURE | SNAG COMMENTS |
|---|---|---|---|---|
| 138 | Washroom 1 | Wall | | Uneven surface. |

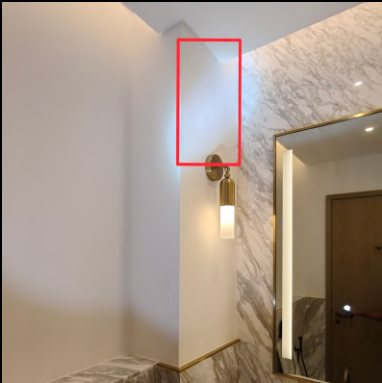
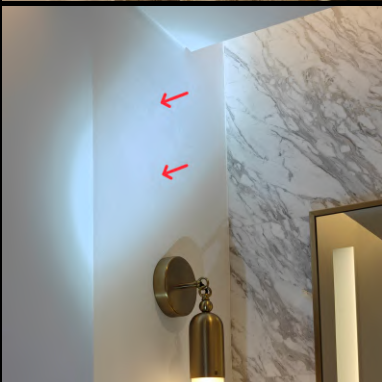
| SI NO | LOCATION | TRADE | PICTURE | SNAG COMMENTS |
|---|---|---|---|---|
| 139 | Washroom 1 | Wall | | Gypsum dust settlements on the wall surface. |

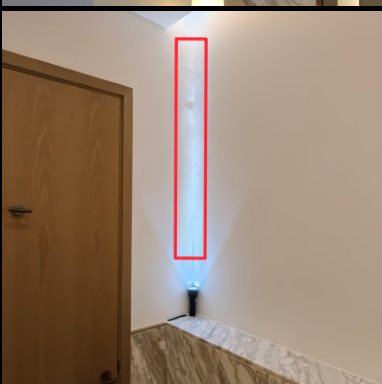
| SI NO | LOCATION | TRADE | PICTURE | SNAG COMMENTS |
|---|---|---|---|---|
| 140 | Washroom 1 | Wall | | Uneven surface & edges. |

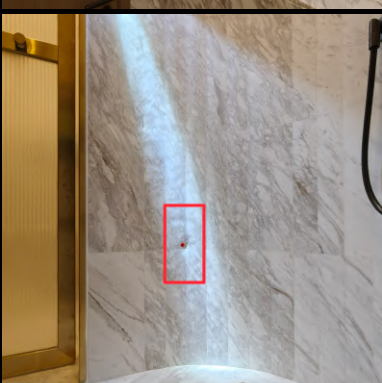
| SI NO | LOCATION | TRADE | PICTURE | SNAG COMMENTS |
|---|---|---|---|---|
| 141 | Washroom 1 | Wall Marbles | | Uneven surface. |

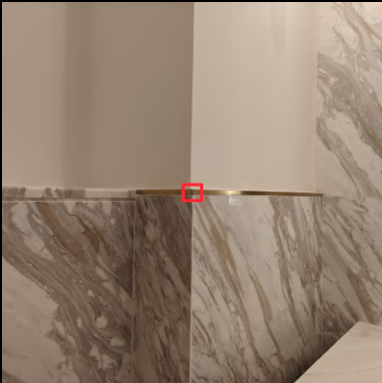
| SI NO | LOCATION | TRADE | PICTURE | SNAG COMMENTS |
|---|---|---|---|---|
| 143 | Washroom 1 | Wall Marbles | | Gaps at tile corner trim. |

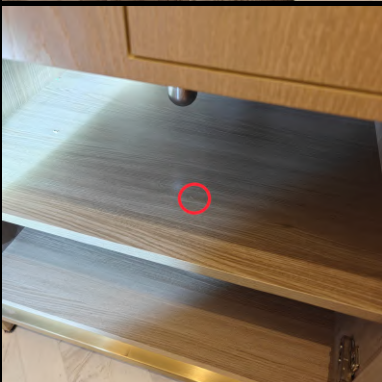
| SI NO | LOCATION | TRADE | PICTURE | SNAG COMMENTS |
|---|---|---|---|---|
| 144 | Washroom 1 | Vanity Cabinet | | Chipped panel surface. |

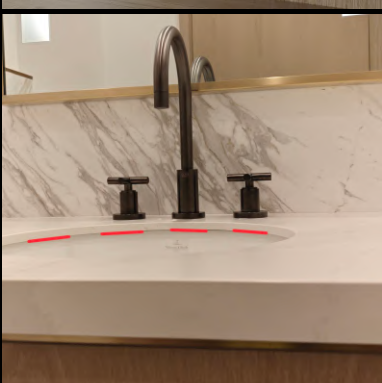
| SI NO | LOCATION | TRADE | PICTURE | SNAG COMMENTS |
|---|---|---|---|---|
| 146 | Washroom 1 | Washbasin | | Inconsistent/Missing silicone between basin & countertop termination. |

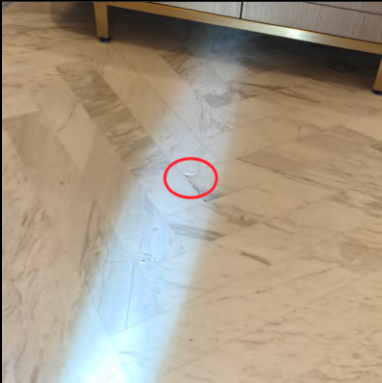
| SI NO | LOCATION | TRADE | PICTURE | SNAG COMMENTS |
|---|---|---|---|---|
| 148 | Washroom 1 | Floor Marbles | | Improper finishing. |

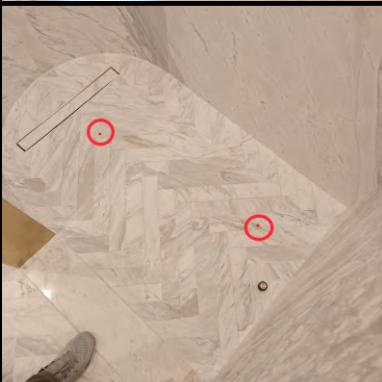
| SI NO | LOCATION | TRADE | PICTURE | SNAG COMMENTS |
|---|---|---|---|---|
| 149 | Washroom 1 | Floor Marbles | | Chipped surface. |

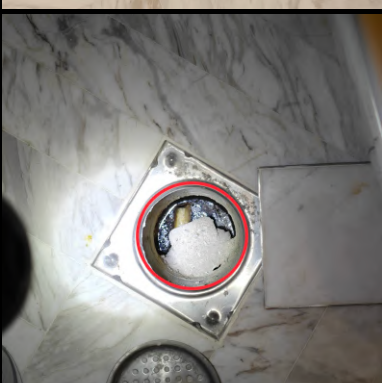
| SI NO | LOCATION | TRADE | PICTURE | SNAG COMMENTS |
|---|---|---|---|---|
| 151 | Washroom 1 | Floor Drain | | Dust & debris inside the drain to be cleaned. |

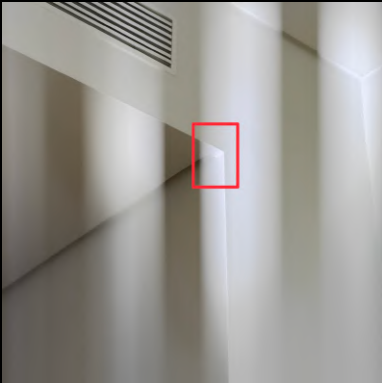
| SI NO | LOCATION | TRADE | PICTURE | SNAG COMMENTS |
|---|---|---|---|---|
| 153 | Master Bedroom | Ceiling | | Cracks & uneven surface. |

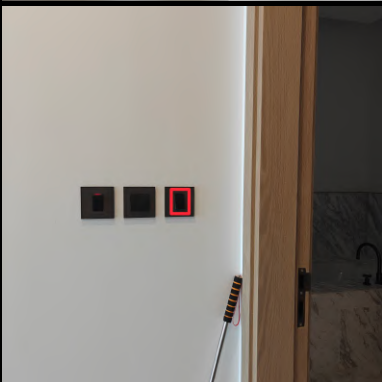
| SI NO | LOCATION | TRADE | PICTURE | SNAG COMMENTS |
|---|---|---|---|---|
| 154 | Master Bedroom | Electric Switch | | Switch button appears tilted in its installation. Proper alignment and fixing are recommended. |

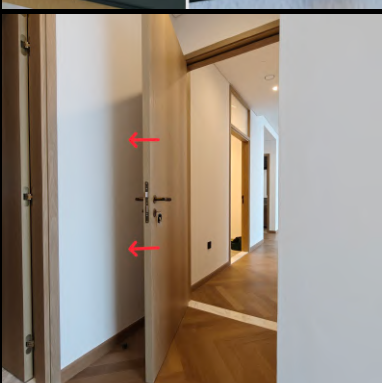
| SI NO | LOCATION | TRADE | PICTURE | SNAG COMMENTS |
|---|---|---|---|---|
| 155 | Master Bedroom | Door & Frame | | Misaligned door swings to open on it's own. |

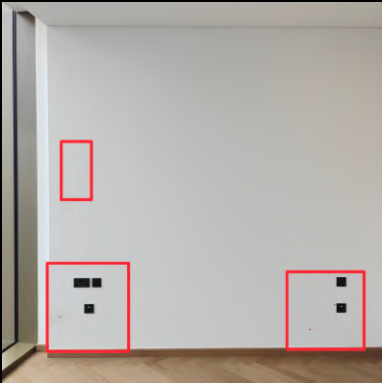
| SI NO | LOCATION | TRADE | PICTURE | SNAG COMMENTS |
|---|---|---|---|---|
| 157 | Master Bedroom | Wall | | Stains marks & uneven surface. |

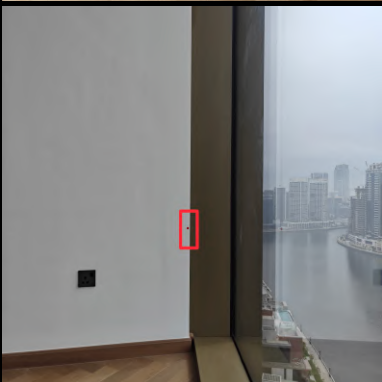
| SI NO | LOCATION | TRADE | PICTURE | SNAG COMMENTS |
|---|---|---|---|---|
| 158 | Master Bedroom | Wall | | Chipped edges. |

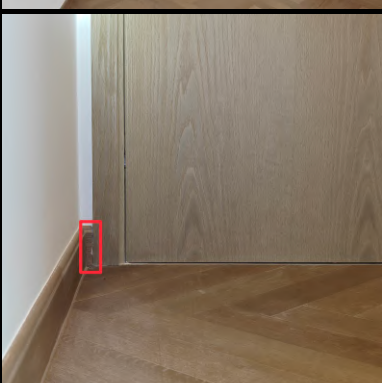
| SI NO | LOCATION | TRADE | PICTURE | SNAG COMMENTS |
|---|---|---|---|---|
| 160 | Master Bedroom | Wooden Flooring | | Gaps between skirting & frame termination. |

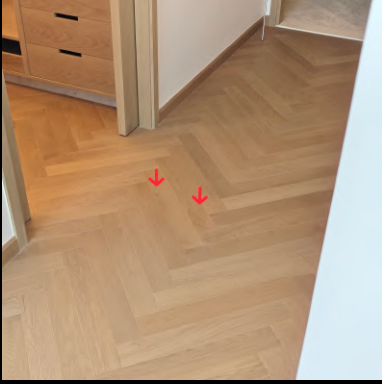
| SI NO | LOCATION | TRADE | PICTURE | SNAG COMMENTS |
|---|---|---|---|---|
| 161 | Master Bedroom | Wooden Flooring | | Noticeable scratches. |

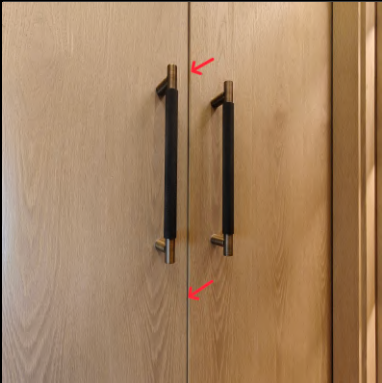
| SI NO | LOCATION | TRADE | PICTURE | SNAG COMMENTS |
|---|---|---|---|---|
| 162 | Master Dressing | Door & Frame | | Misaligned/Unleveled door closure - door do not close at same level. |
