**PROPERTY NINJA**  
BUILDING INSPECTION

# WELCOME TO YOUR PROPERTY NINJA REPORT

**PROPERTY ADDRESS:** X X X X X X , Dubai.

During Snagging Property Ninja noticed **234 Snag** Issues to be rectified for **App X X X X X X , Dubai.**

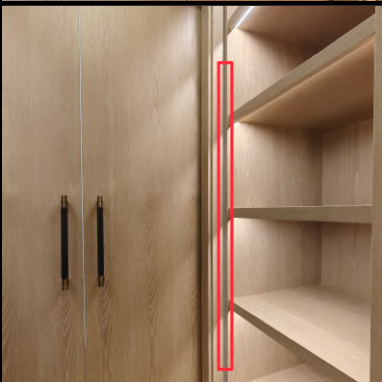
| SI NO | LOCATION | TRADE | PICTURE | SNAG COMMENTS |
|---|---|---|---|---|
| 163 | Master Dressing | Wall | | Improve wall finishing between door & wardrobe frame gaps. |

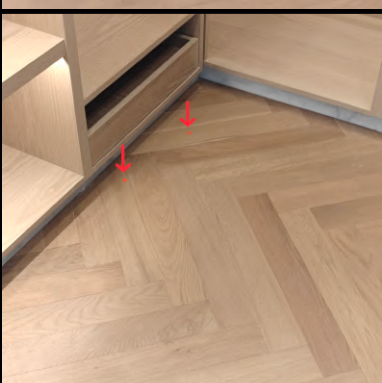
| SI NO | LOCATION | TRADE | PICTURE | SNAG COMMENTS |
|---|---|---|---|---|
| 165 | Master Dressing | Wooden Flooring | | Scratches & damages. |

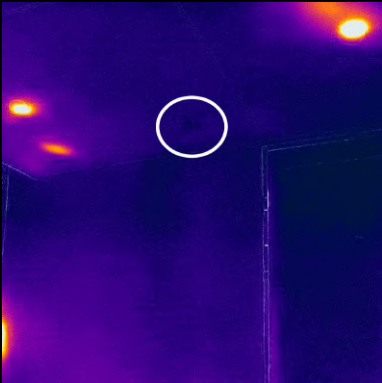
| SI NO | LOCATION | TRADE | PICTURE | SNAG COMMENTS |
|---|---|---|---|---|
| | Master Washroom | MEP | | Moisture detected above ceiling, possibly from plumbing leak or condensation from FCU components. |

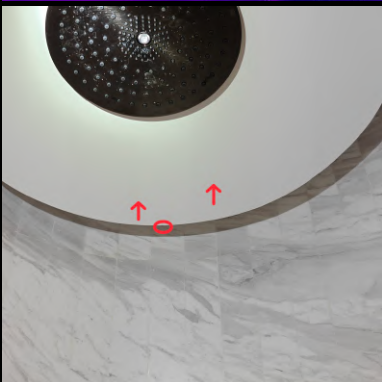
| SI NO | LOCATION | TRADE | PICTURE | SNAG COMMENTS |
|---|---|---|---|---|
| 167 | Master Washroom | Ceiling | | Chipped edges & engraved scratches. |

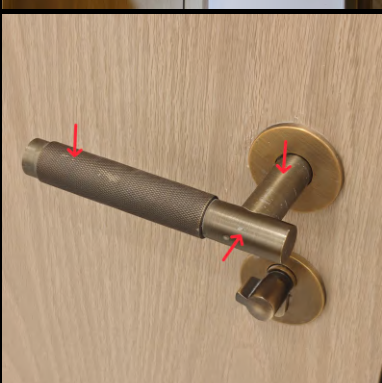
| SI NO | LOCATION | TRADE | PICTURE | SNAG COMMENTS |
|---|---|---|---|---|
| 169 | Master Washroom | Door & Frame | | Paint & polish damages on door handle. |

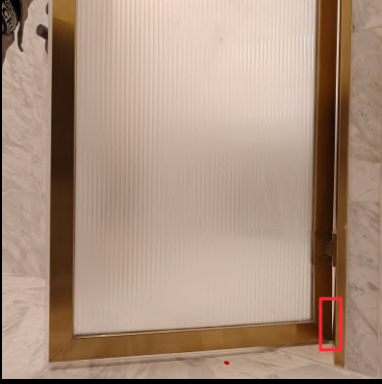
| SI NO | LOCATION | TRADE | PICTURE | SNAG COMMENTS |
|---|---|---|---|---|
| 170 | Master Washroom | Aluminium Door & Frame | | Misaligned door touch the frame while opening & closing in shower area. |

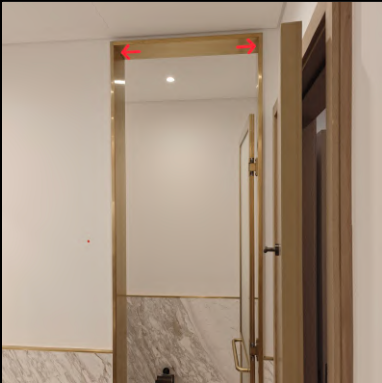
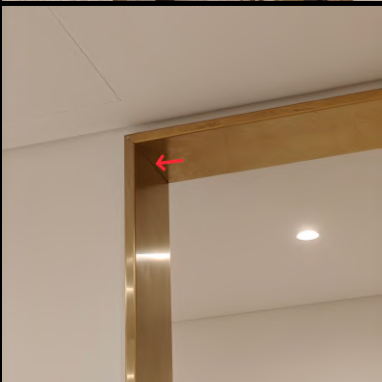
| SI NO | LOCATION | TRADE | PICTURE | SNAG COMMENTS |
|---|---|---|---|---|
| 171 | Master Washroom | Aluminium Door & Frame | | Gaps at frame joints. |

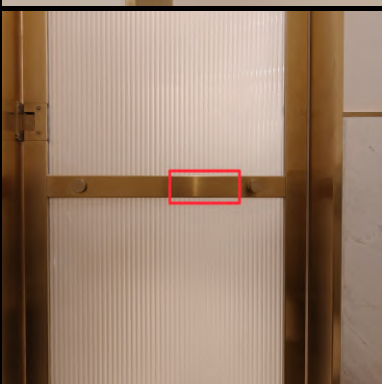
| SI NO | LOCATION | TRADE | PICTURE | SNAG COMMENTS |
|---|---|---|---|---|
| 172 | Master Washroom | Aluminium Door & Frame | | Scratches on frame. |

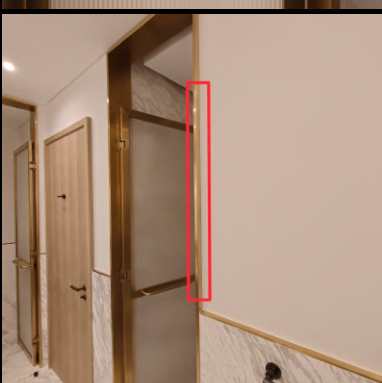
| SI NO | LOCATION | TRADE | PICTURE | SNAG COMMENTS |
|---|---|---|---|---|
| 173 | Master Washroom | Aluminium Door & Frame | | Stains on frame. |

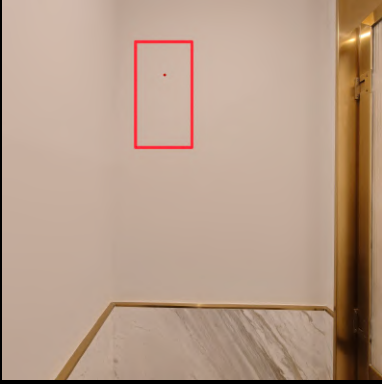
| SI NO | LOCATION | TRADE | PICTURE | SNAG COMMENTS |
|---|---|---|---|---|
| 174 | Master Washroom | Wall | | Chipped surface. |

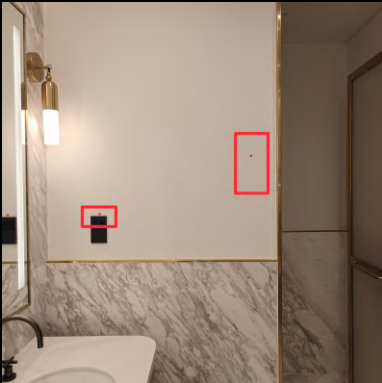
| SI NO | LOCATION | TRADE | PICTURE | SNAG COMMENTS |
|---|---|---|---|---|
| 175 | Master Washroom | Wall | | Engraved scratches on surface. Poor finishing around socket termination. |

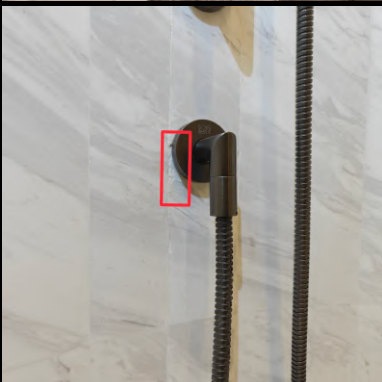
| SI NO | LOCATION | TRADE | PICTURE | SNAG COMMENTS |
|---|---|---|---|---|
| 176 | Master Washroom | Wall Marbles | | Chipped/Damaged surface. |

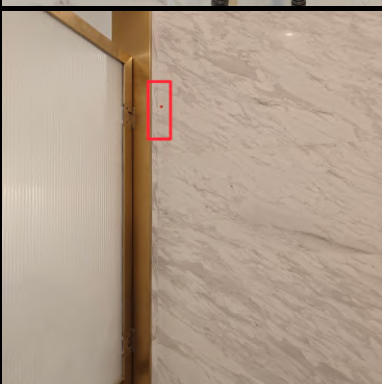
| SI NO | LOCATION | TRADE | PICTURE | SNAG COMMENTS |
|---|---|---|---|---|
| 177 | Master Washroom | Wall Marbles | | Improper crack rectification - poor finishing. |

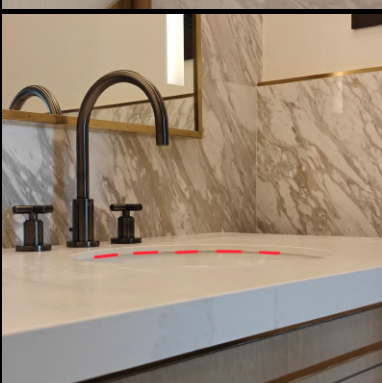
| SI NO | LOCATION | TRADE | PICTURE | SNAG COMMENTS |
|---|---|---|---|---|
| 178 | Master Washroom | Washbasin | | Inconsistent/Missing silicone between basin & countertop termination. |

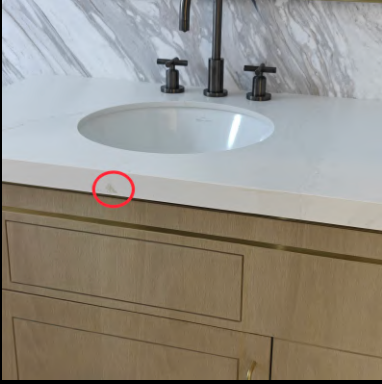
| SI NO | LOCATION | TRADE | PICTURE | SNAG COMMENTS |
|---|---|---|---|---|
| 179 | Master Washroom | Vanity Counter | | Noticeable stains. |

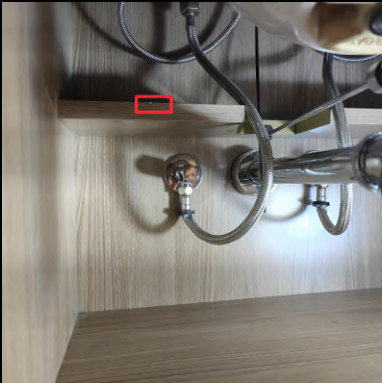
| SI NO | LOCATION | TRADE | PICTURE | SNAG COMMENTS |
|---|---|---|---|---|
| 180 | Master Washroom | Vanity Cabinet | | Chipped/Damaged edges. |

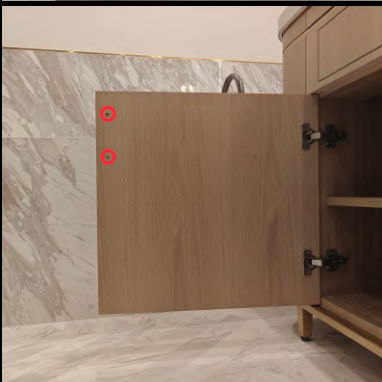
| SI NO | LOCATION | TRADE | PICTURE | SNAG COMMENTS |
|---|---|---|---|---|
| 181 | Master Washroom | Vanity Cabinet | | Missing screw hole dummy. |

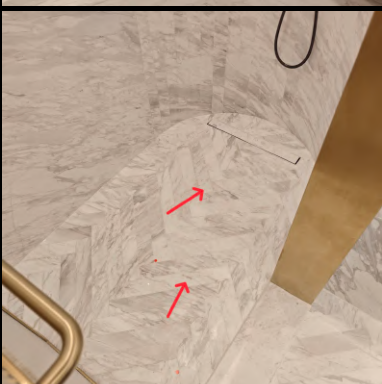
| SI NO | LOCATION | TRADE | PICTURE | SNAG COMMENTS |
|---|---|---|---|---|
| 182 | Master Washroom | Floor Slope | | Inadequate floor slope towards shower drain - water stagnant. |

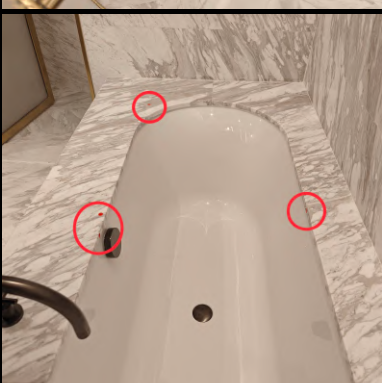
| SI NO | LOCATION | TRADE | PICTURE | SNAG COMMENTS |
|---|---|---|---|---|
| 183 | Master Washroom | Bathtub Counter | | Chipped/Damaged counter surface & edges. |

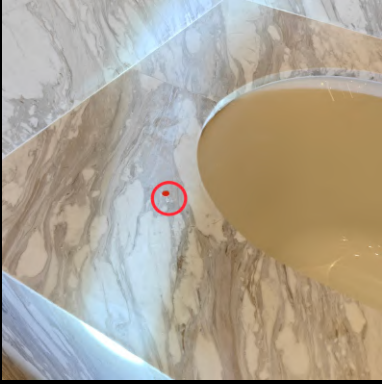
| SI NO | LOCATION | TRADE | PICTURE | SNAG COMMENTS |
|---|---|---|---|---|
| 183 | Master Washroom | Bathtub Counter | | Chipped counter surface. |

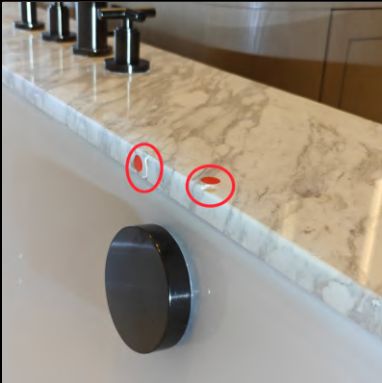
| SI NO | LOCATION | TRADE | PICTURE | SNAG COMMENTS |
|---|---|---|---|---|
| | Master Washroom | Bathtub Counter | | Chipped counter edges. |

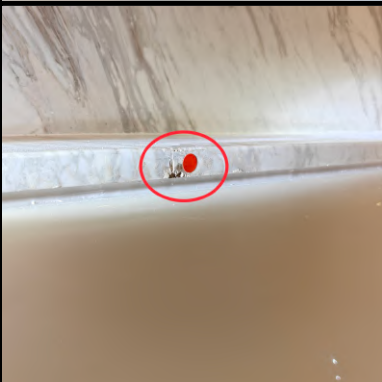
| SI NO | LOCATION | TRADE | PICTURE | SNAG COMMENTS |
|---|---|---|---|---|
| | Master Washroom | Bathtub Counter | | Chipped counter edges. |

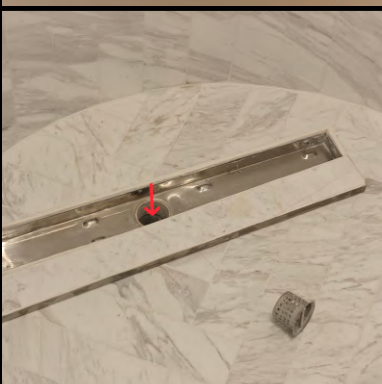
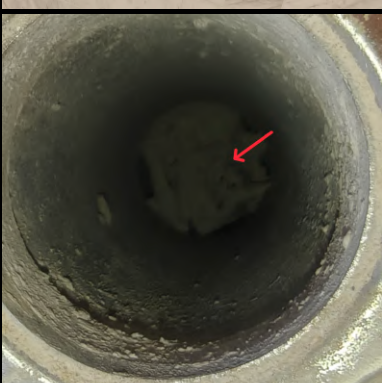
| SI NO | LOCATION | TRADE | PICTURE | SNAG COMMENTS |
|---|---|---|---|---|
| 184 | Master Washroom | Shower Drain | | Dust & debris inside drain to be cleaned. |

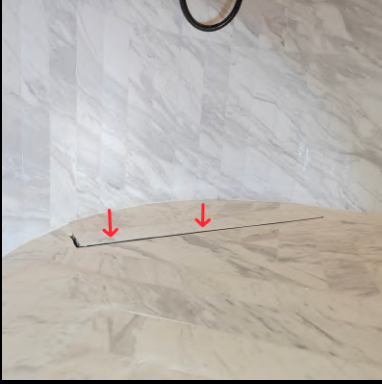
| SI NO | LOCATION | TRADE | PICTURE | SNAG COMMENTS |
|---|---|---|---|---|
| 185 | Master Washroom | Shower Drain | | Shower drain do not close properly at same level. |

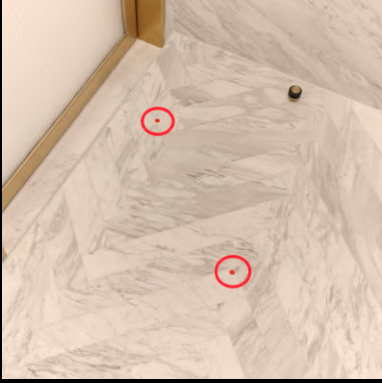
| SI NO | LOCATION | TRADE | PICTURE | SNAG COMMENTS |
|---|---|---|---|---|
| 186 | Master Washroom | Floor Marbles | | Chipped surface. |

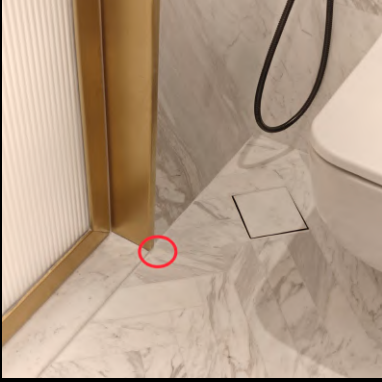
| SI NO | LOCATION | TRADE | PICTURE | SNAG COMMENTS |
|---|---|---|---|---|
| 187 | Master Washroom | Floor Marbles | | Chipped marbles filled with fillers looks unsightly. |
